HouseCheck

Inspection Report

22 Main Road, Sampleville

Inspection prepared for: Sample Client
Date of Inspection: 5/24/2013 Time: 10:00 AM
Age of Home: ± 10 years
Weather: Clear

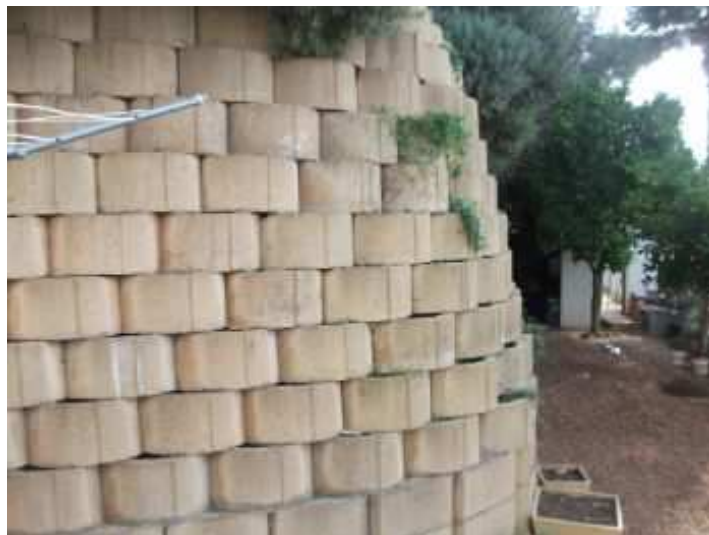
House north side - retaining wall appears to be structurally sound

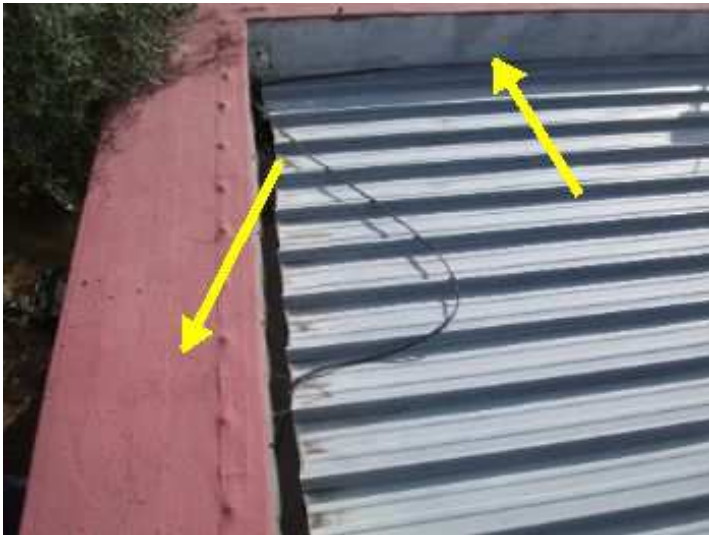
Garage roof - flashings and top of parapet walls properly waterproofed

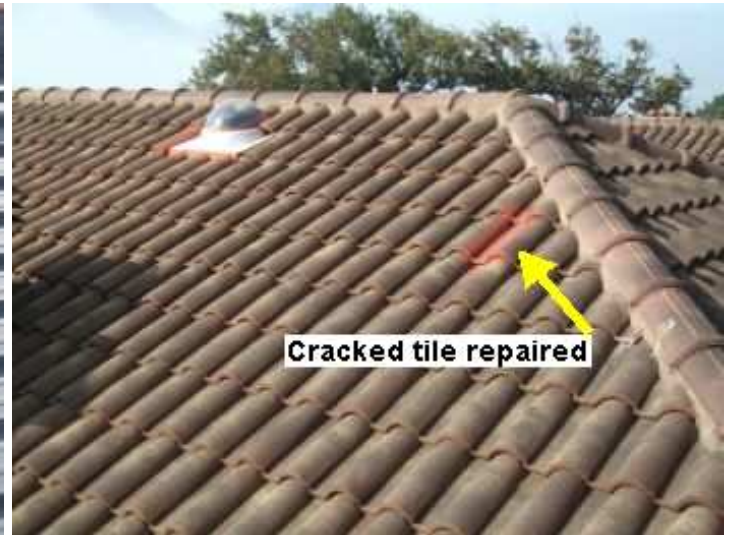
House roof - generally in good condition

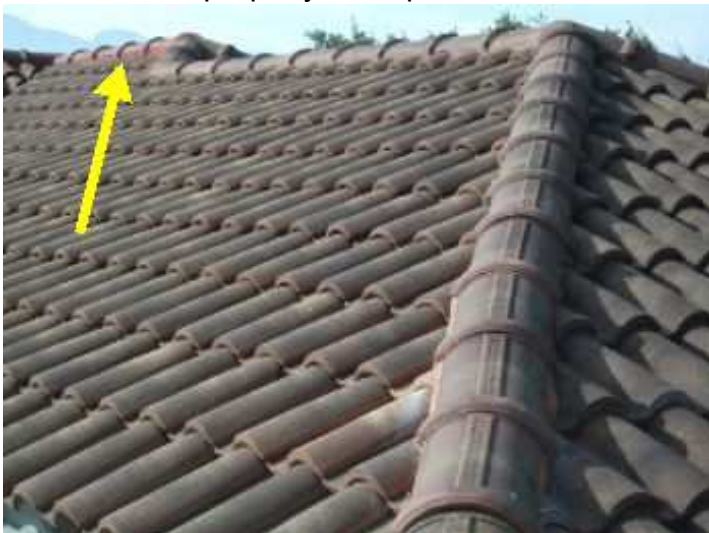
House roof (above main bedroom) - ridges waterproofed

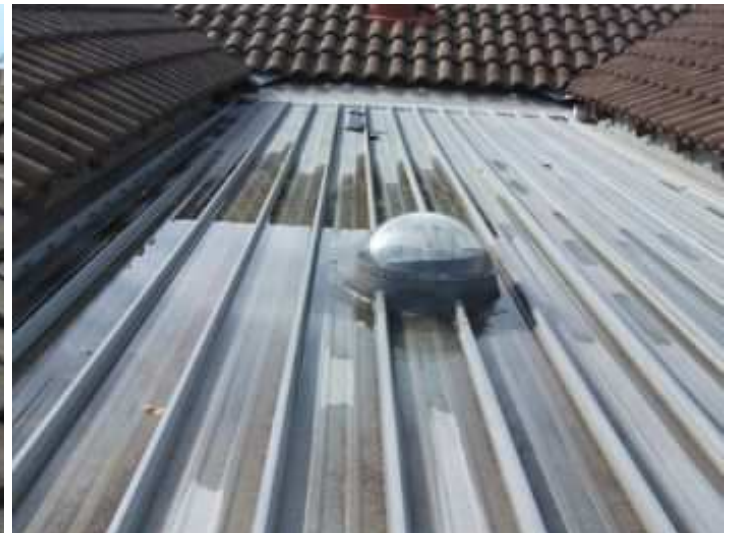
Entrance hall - standing water on roof sheets

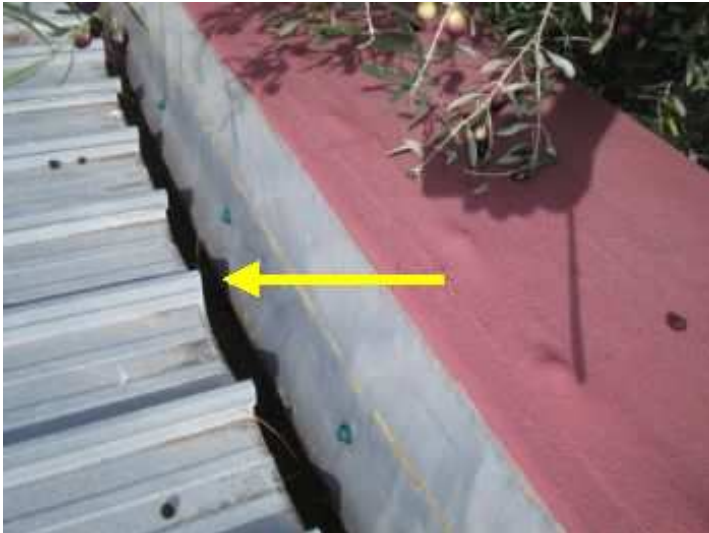
- No gutters to tiled roofs, only to two flat roofs.
- Gutters generally in good condition.
- MAINTENANCE ISSUES:
- Gutters were dirty. Should be cleaned regularly.

Garage roof - keep gutters clean

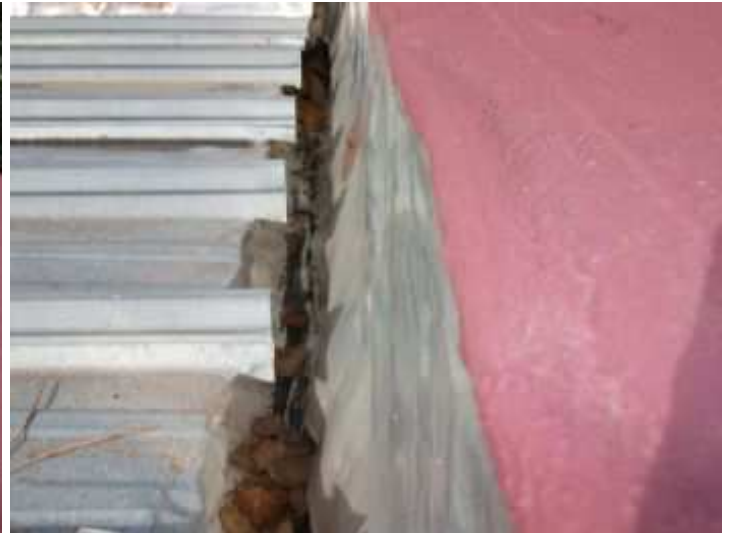
Entrance hall roof - keep gutters clean

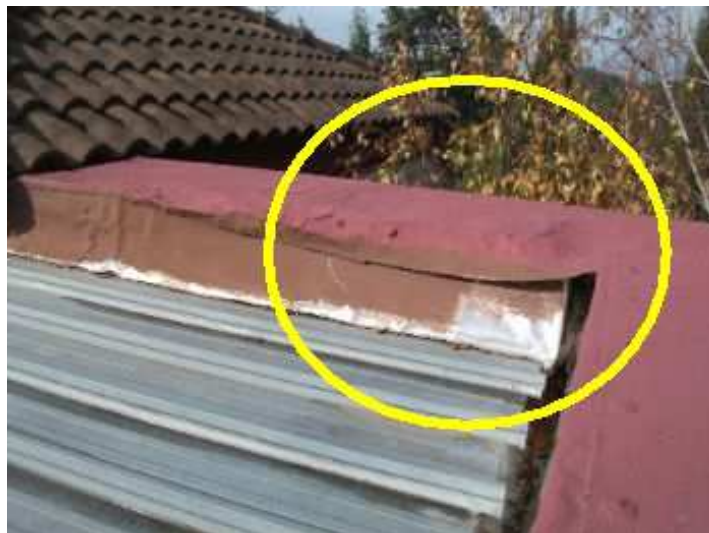
- Roof flashings generally in good condition.
- Waterproofing to top of parapet walls in good condition.
- Metal flashings to abutments, brick chimneys or other projections generally in good condition.
- MAINTENANCE ISSUES:
- Brick chimney crown not sloped and possibly not waterproofed. Water penetration possible.
- Entrance hall roof - untidy flashing configuration.

Entrance hall roof south west corner - untidy waterproofing / flashing

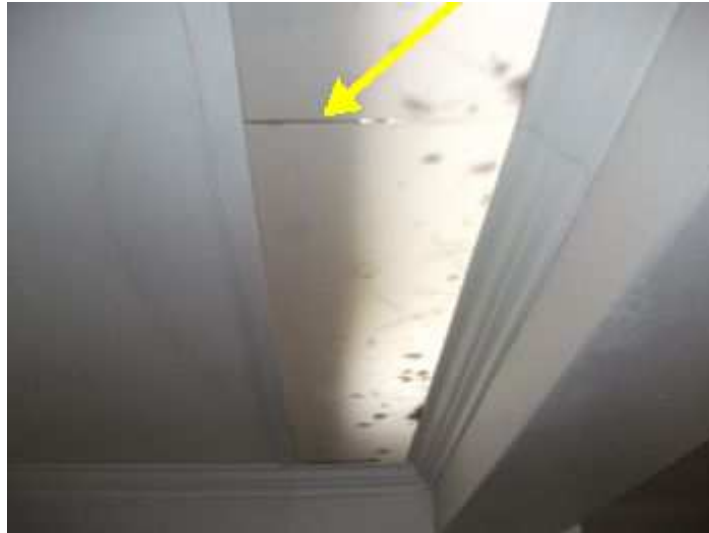
- Skylights generally in good condition.
- No water leaks around skylights observed.
- MAINTENANCE ISSUES:
- Entrance hall - skylight glazing dirty. Ensure skylight is properly waterproofed after cleaning.

Entrance hall - skylight dirty - movement between panels

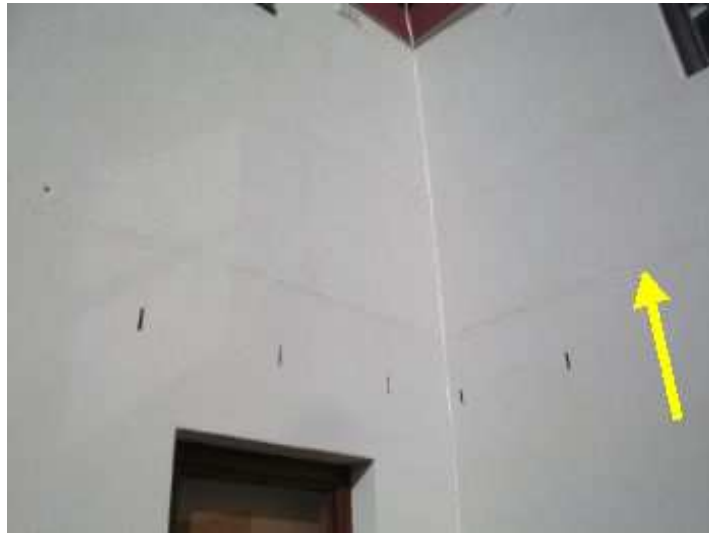
Guest bedroom east facing wall - possible water ingress at control joint caused damp internally - walls recently painted

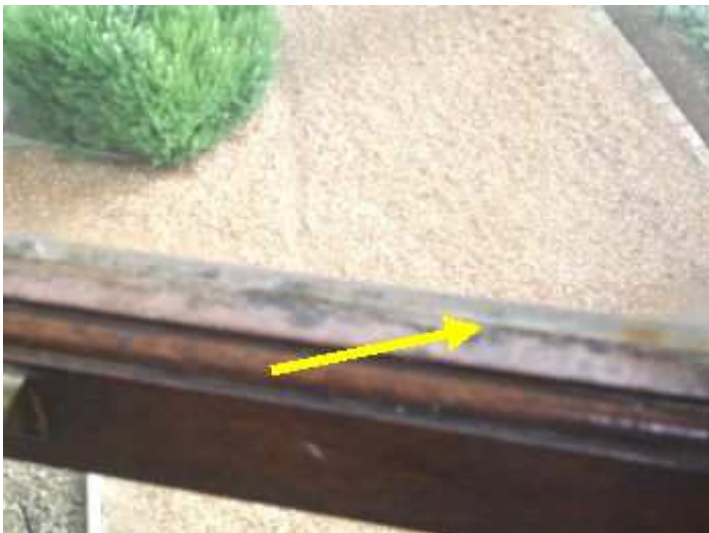
- Windows frames generally in good condition.
- BURGLAR BARS:
- No burglar bars installed.
- MAINTENANCE ISSUES:
- Glazing putty dried out and caused water ingress between glass and frame. As a result some window frames were weathered and or water marked internally. Consider sealing or replacing putty to prevent further deterioration of timber frame.

General comment - water ingress between frame and glass at some windows

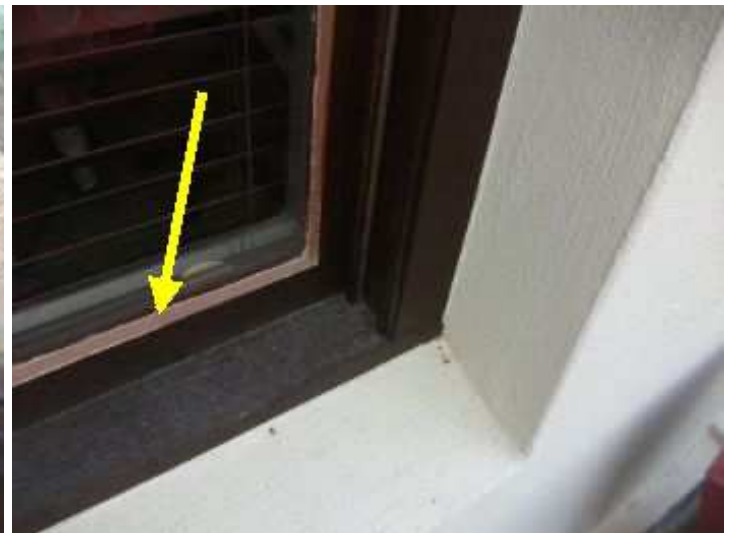
First floor lounge - some window panes with new glazing putty - should be varnished to prevent putty from drying out

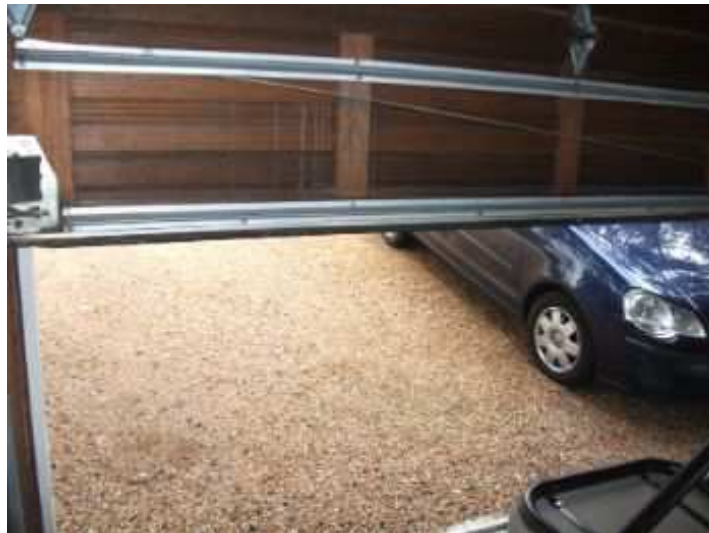
Double garage door operational

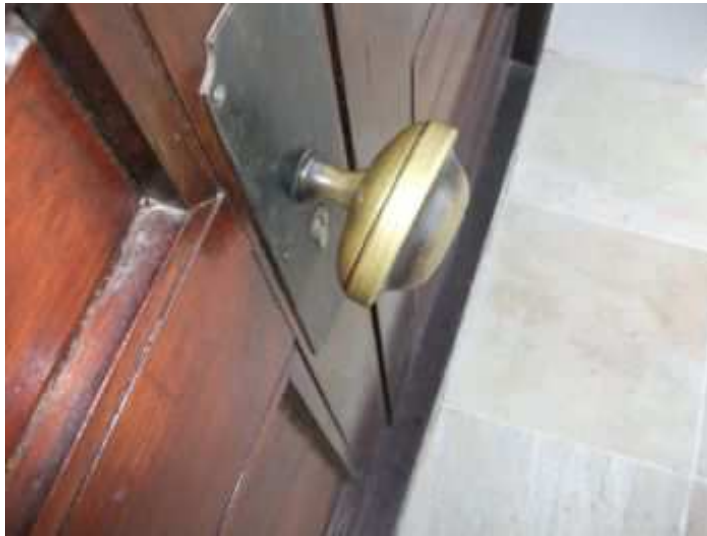
Front door - loose door knob - externally and internally

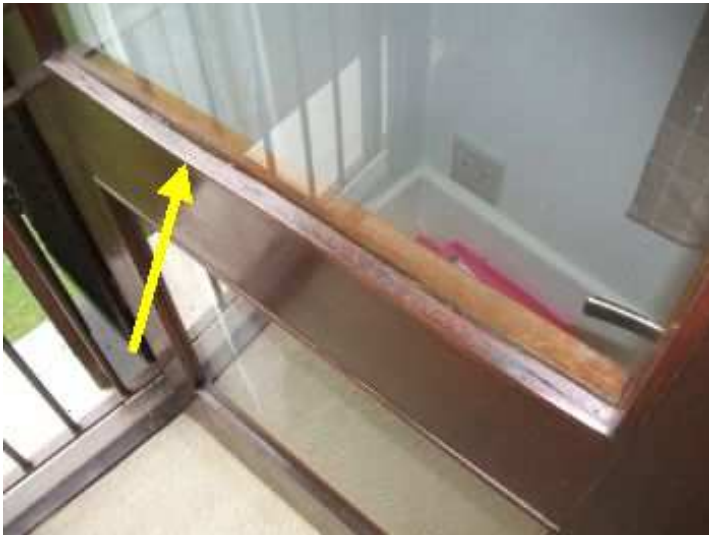
Main bedroom - cracked and warped glazing timber strip

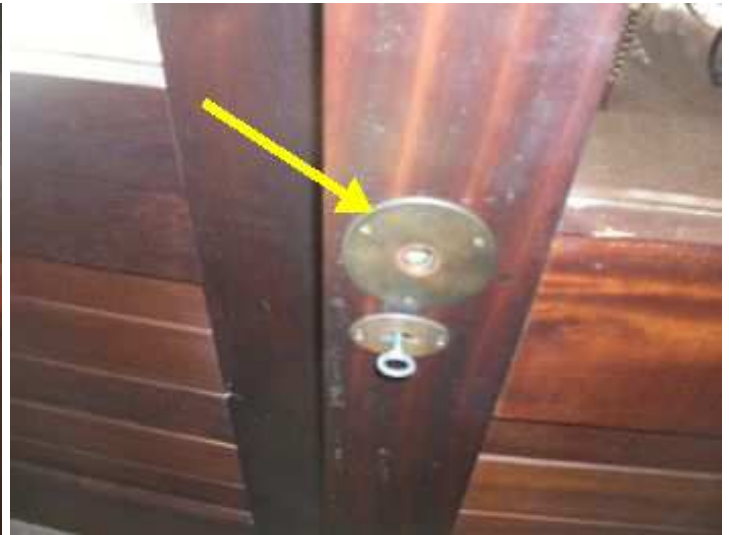
Family room - door knob removed

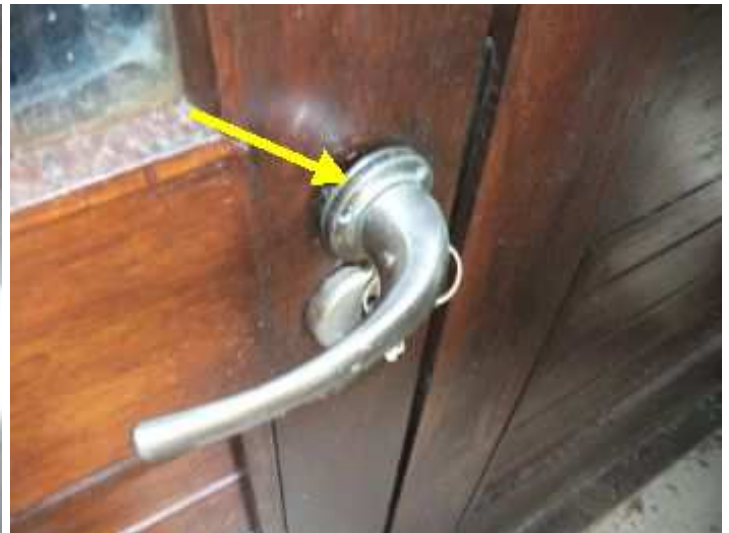
Guest bedroom - door handle cover plate removed

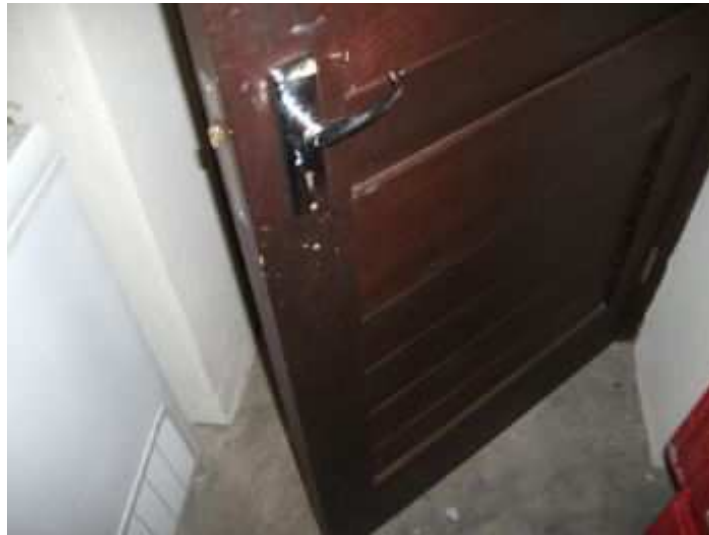
- Normal door installed as a fire door - this is a safety concern and not as per National Building Regulations.

First floor lounge to garage - no fire door installed - does not comply with regulations

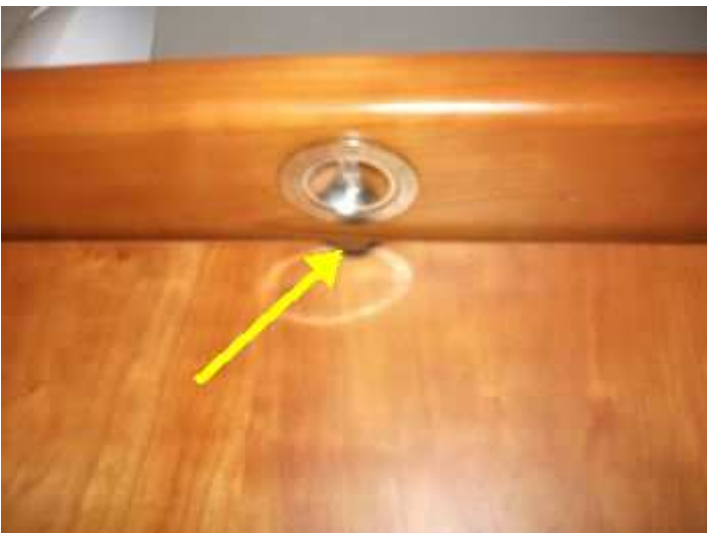
Kitchen south wall - burn mark on door caused by heat from down lighter

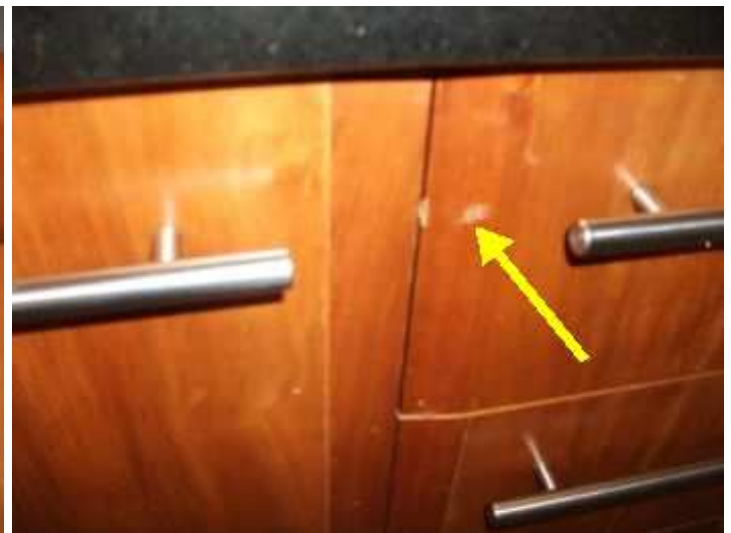
Kitchen - general wear and tear marks to some cupboards

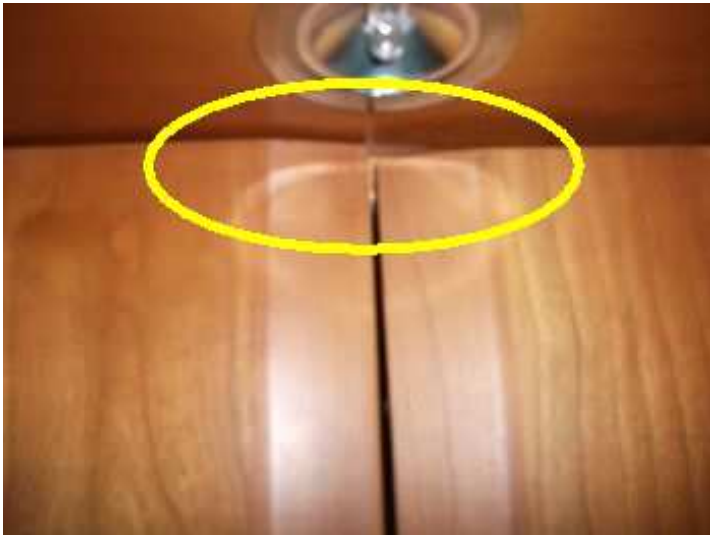
Kitchen - some cupboard doors should be realigned

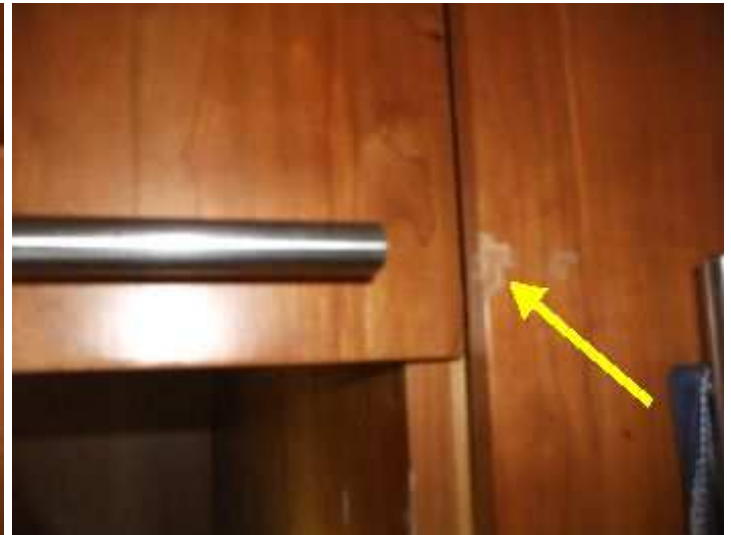
Laundry - general wear and tear marks to some cupboards - doors require realignment

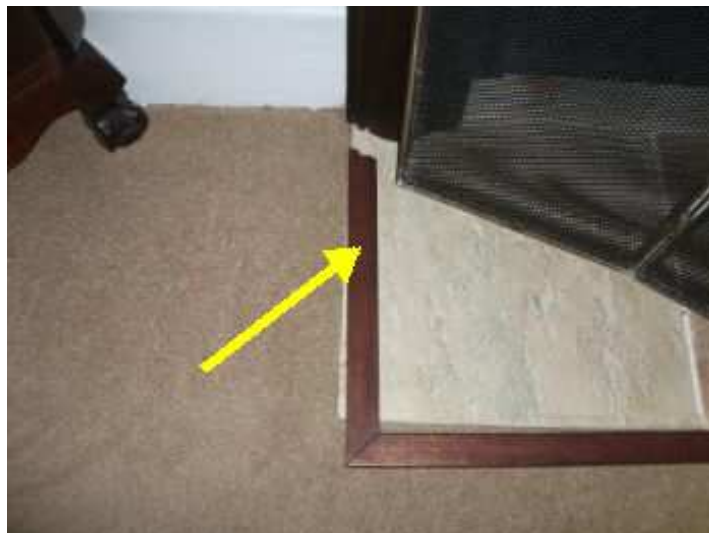
- Dining room - hearth (tiled floor in front of fireplace) timber edging loose.

Dining room - fireplace hearth timber surround loose

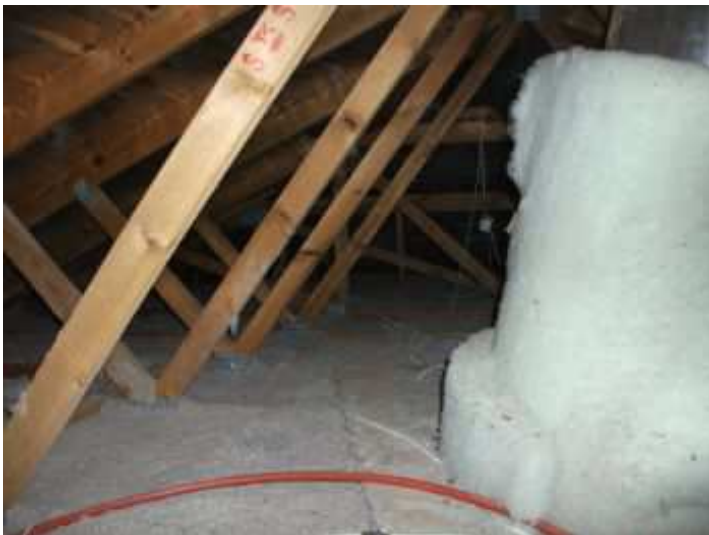
Roof structure - structurally sound and in good condition

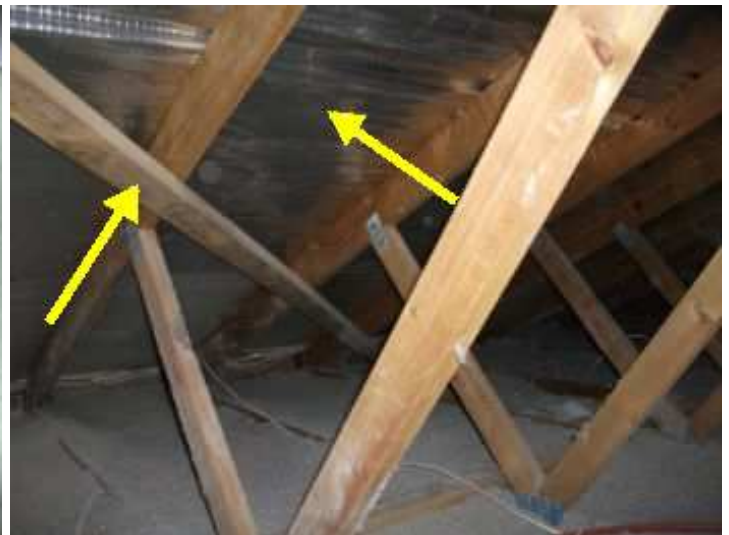
Roof structure - insulation in good condition and bracing correctly installed

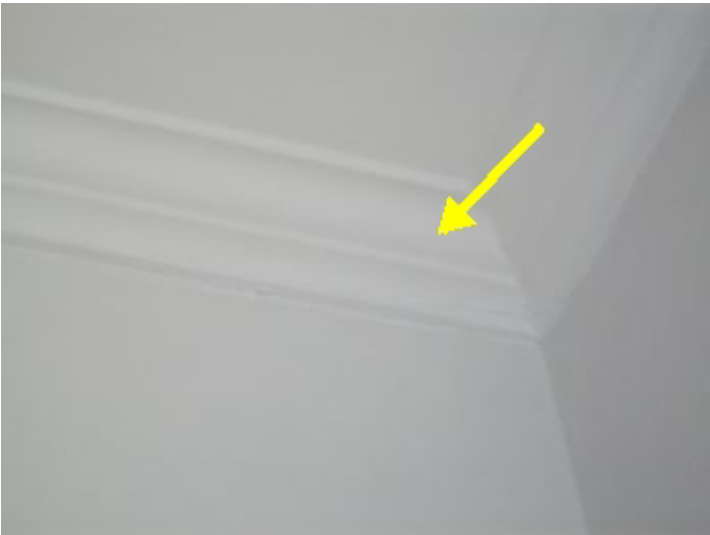
Bedroom 1 - movement cracks in cornices

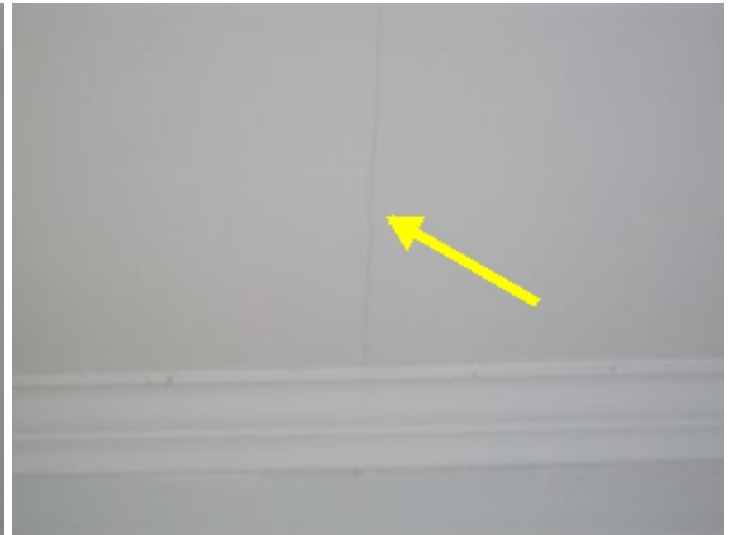
Bedroom 1 north wall - movement crack between ceiling boards

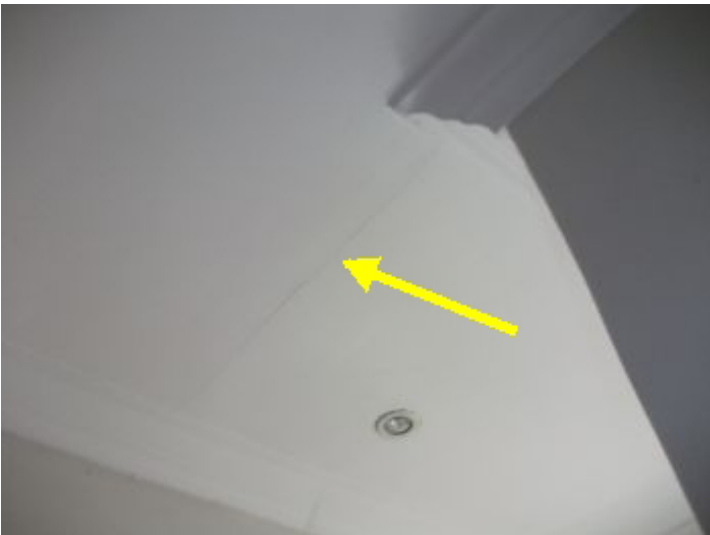
Bedroom 1 en-suite bathroom - movement crack between ceiling boards

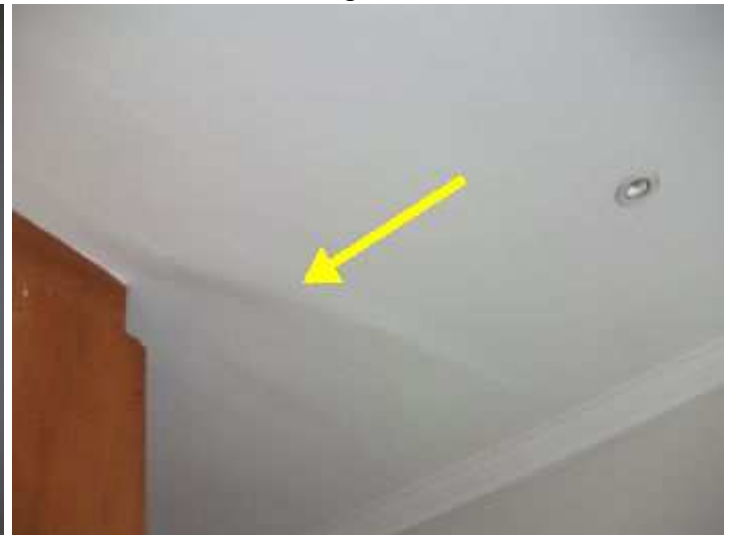
Main bedroom (between dressing area and bedroom) - movement crack between ceiling boards

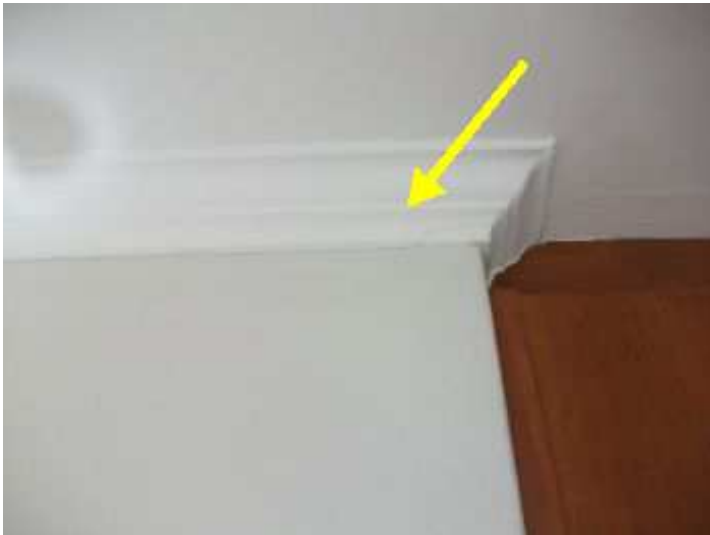
Main bedroom - movement cracks in cornice

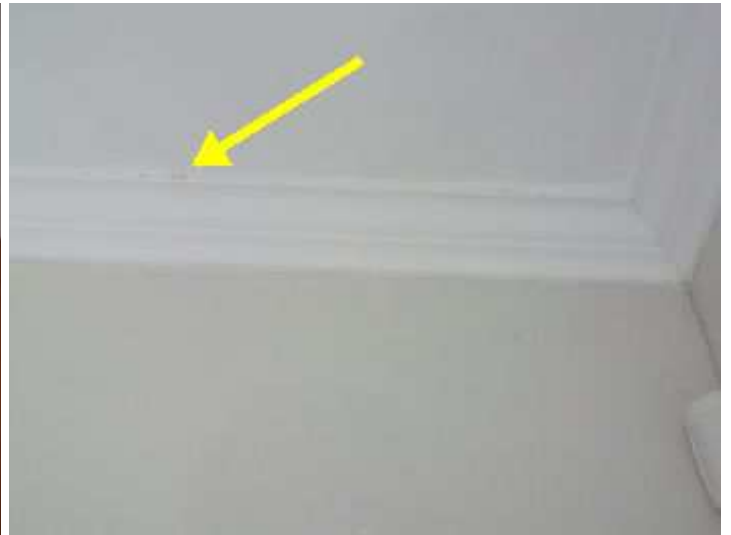
Main bedroom north east corner - movement cracks between cornice and ceiling boards

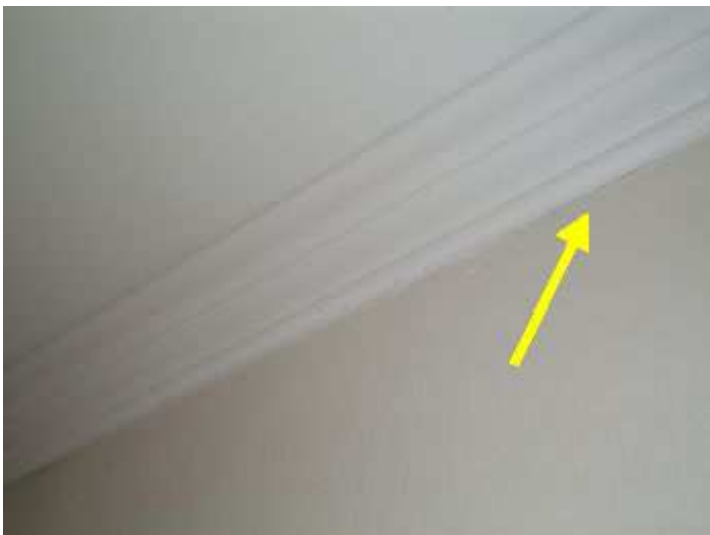
First floor lounge west wall - movement cracks between cornice and wall

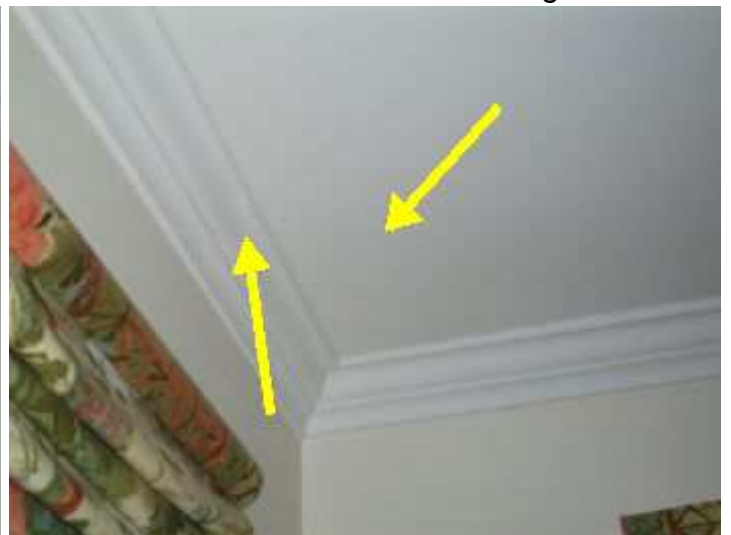
Study south west corner - movement cracks in ceiling and cornice

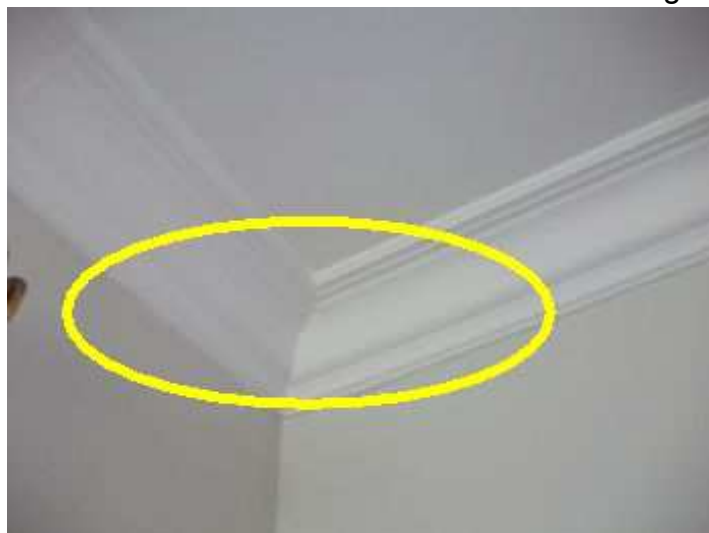
Dining room south west corner - movement cracks in cornice

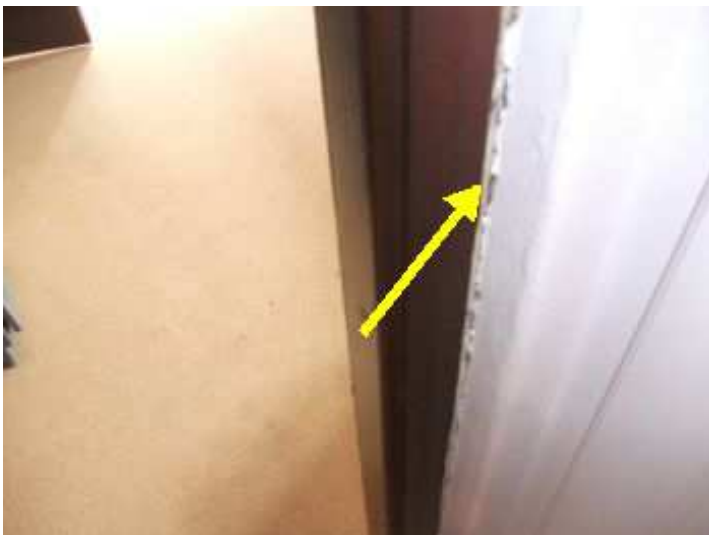
Bedroom 1 - minor door frame movement resulted in cracked plaster

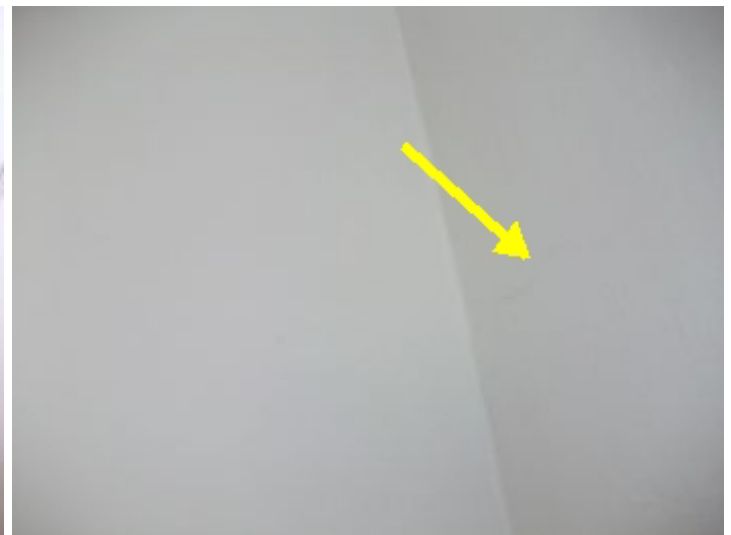
Bedroom 1 north east corner - repaired settlement cracks

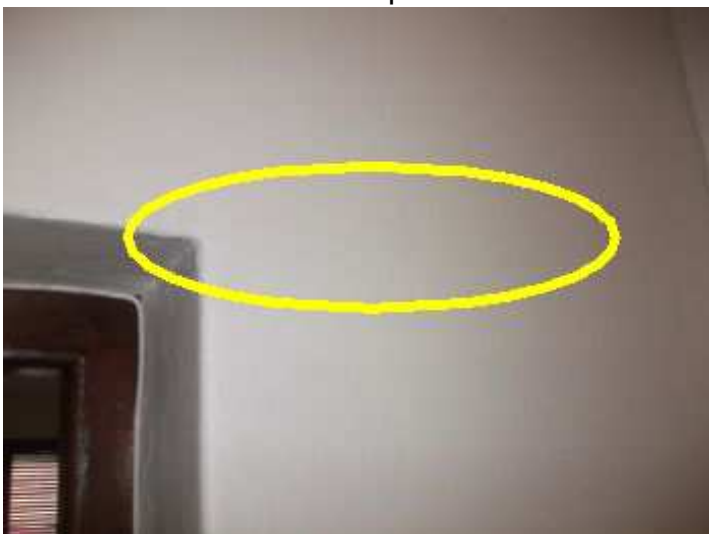
First floor lounge door - movement or settlement crack at door head

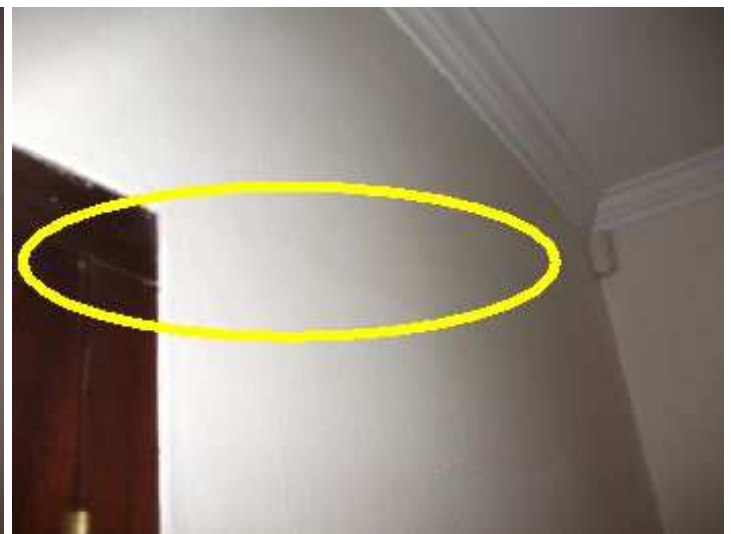
Study north wall - movement or settlement crack at door head

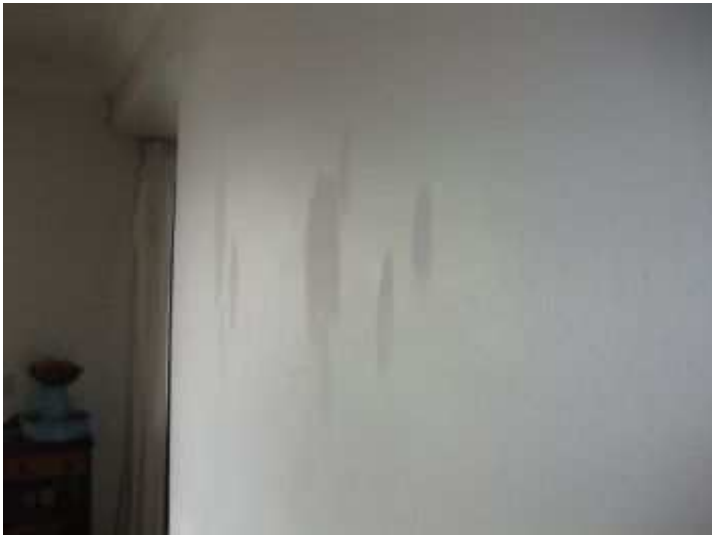
Family room south wall - repair marks on wall

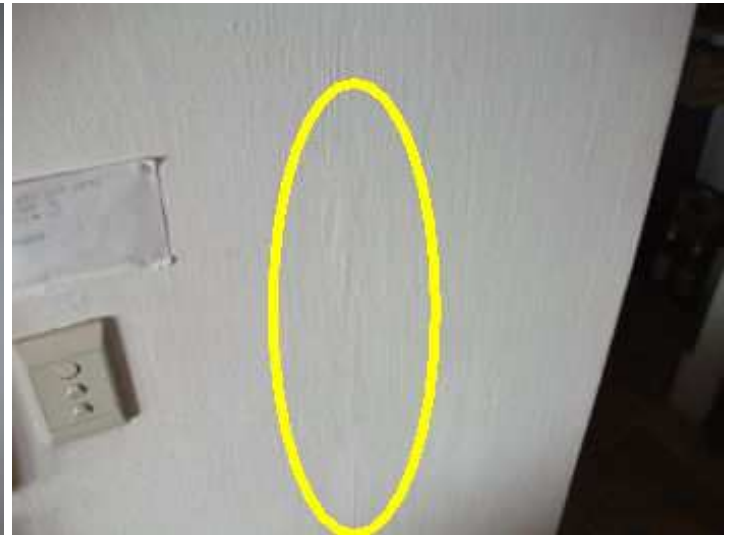
Kitchen to wine cellar - repaired crack visible

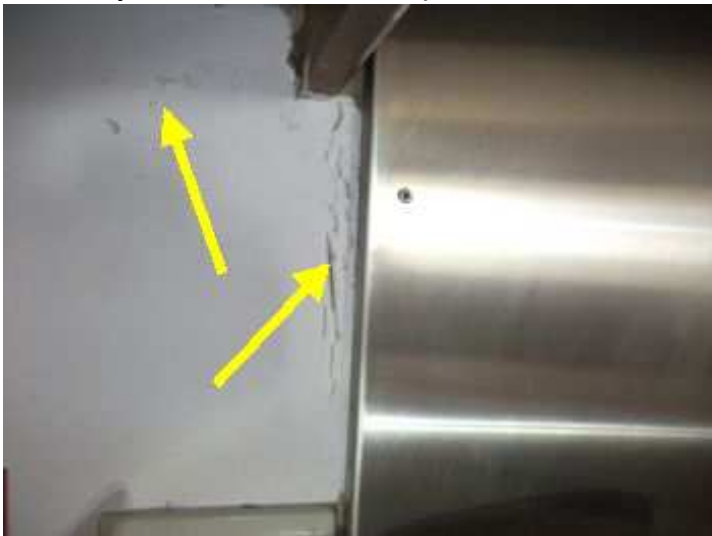
Kitchen west wall - flaking paint next to stove splashback

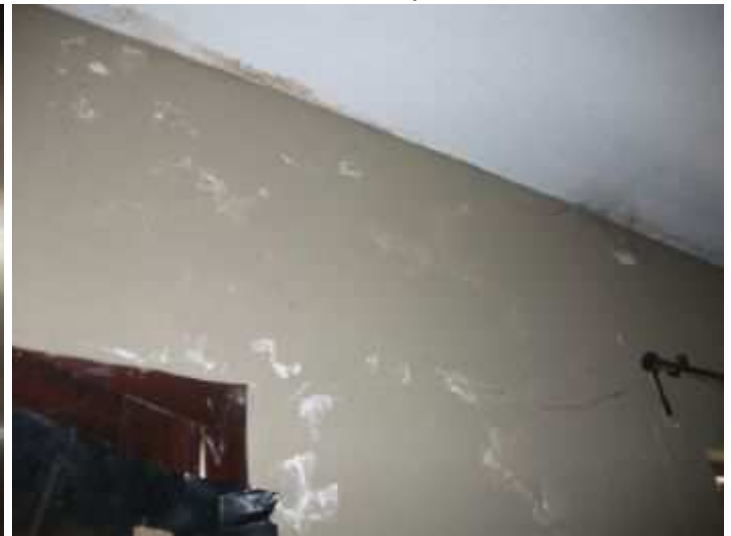
Guest bedroom east wall - penetrating damp

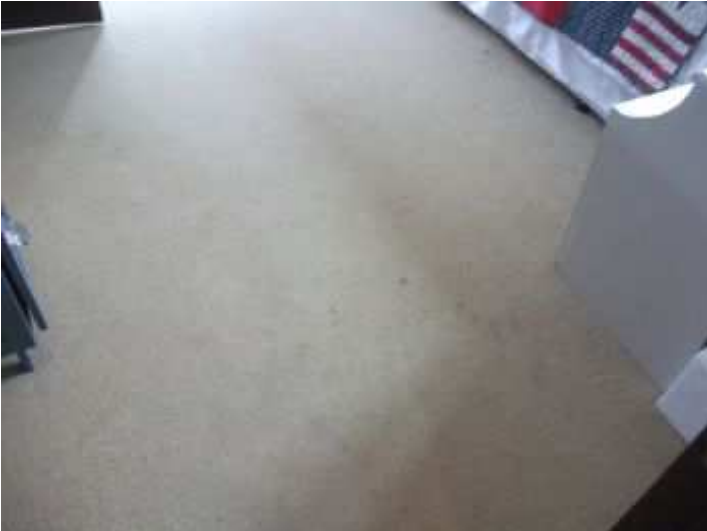
Bedroom 1 - carpets with general wear and tear marks

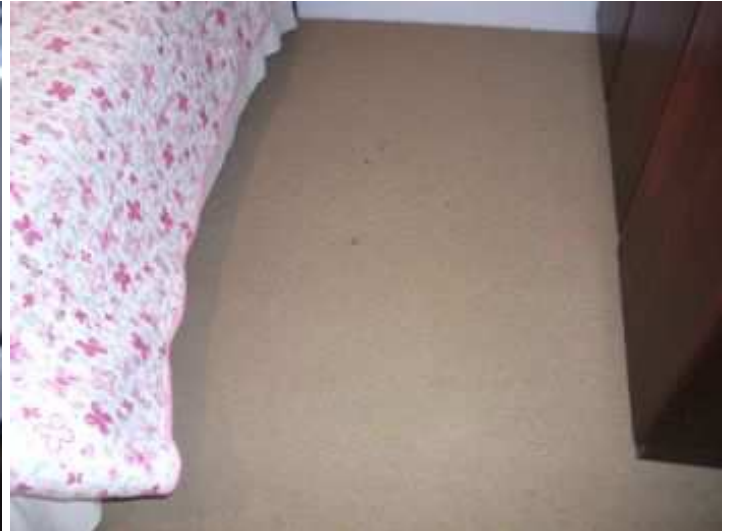
Bedroom 2 - carpets with general wear and tear marks

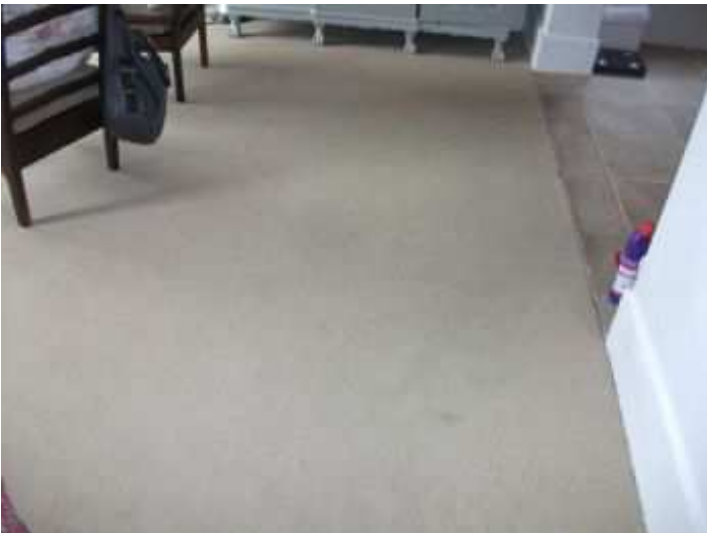
Main bedroom - carpets with general wear and tear marks

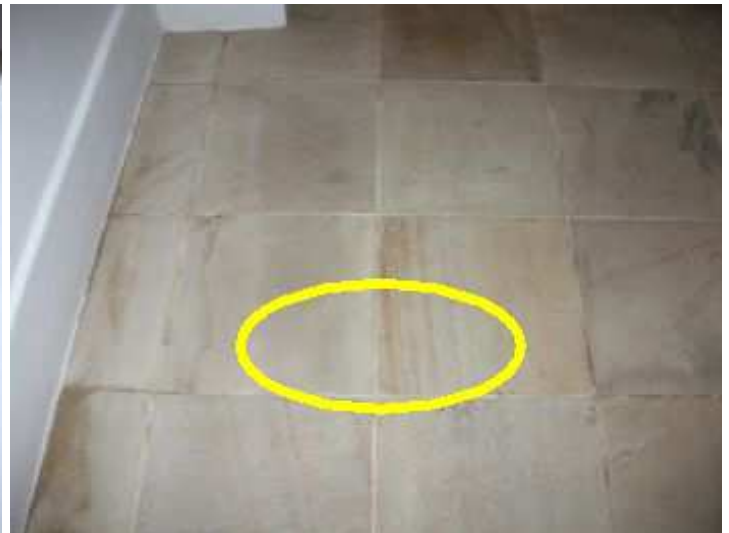
First floor passage (at main bedroom door) - cracked floor tiles

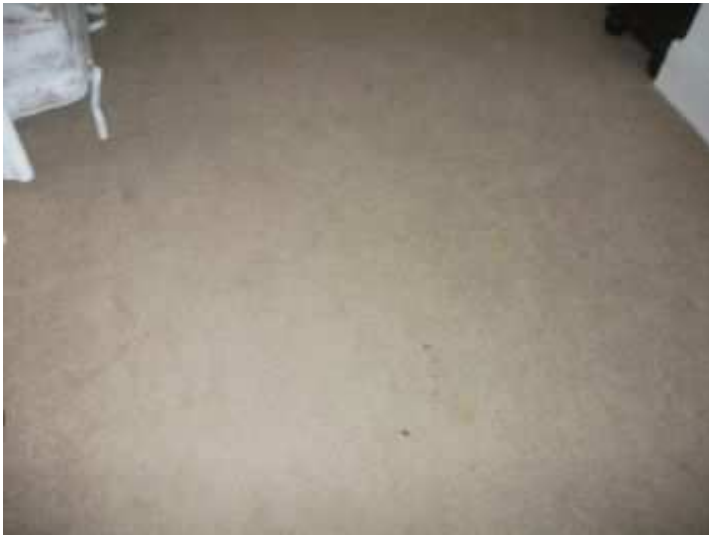
Dining room - carpets with general wear and tear marks

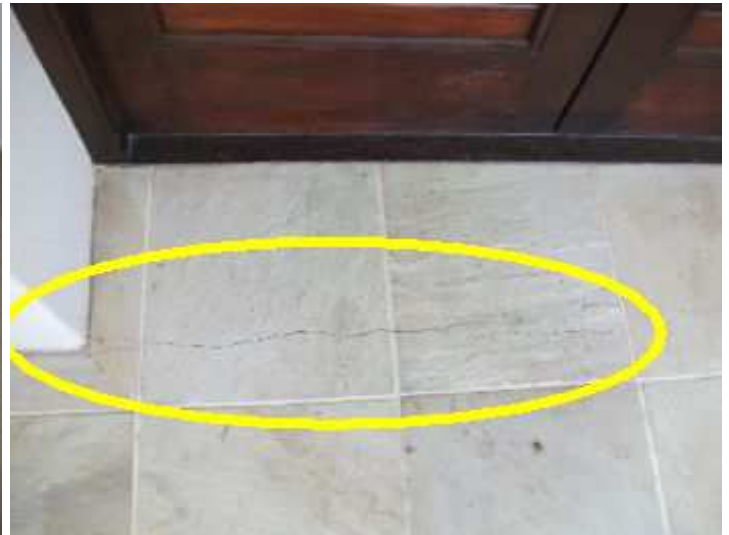
Front door - settlement crack at front door

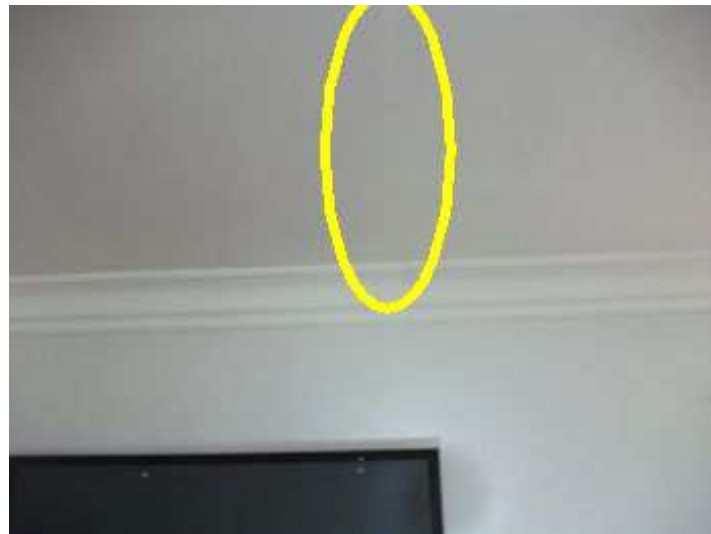
- Suspended concrete floor structure at first floor level appears to be in general good condition and structurally sound.
- MAINTENANCE ISSUES:
- Settlement and or movement cracks in suspended concrete floor slab at first floor level observed. These cracks appear to be not structural at present.

Family room north wall - movement crack in ceiling structure

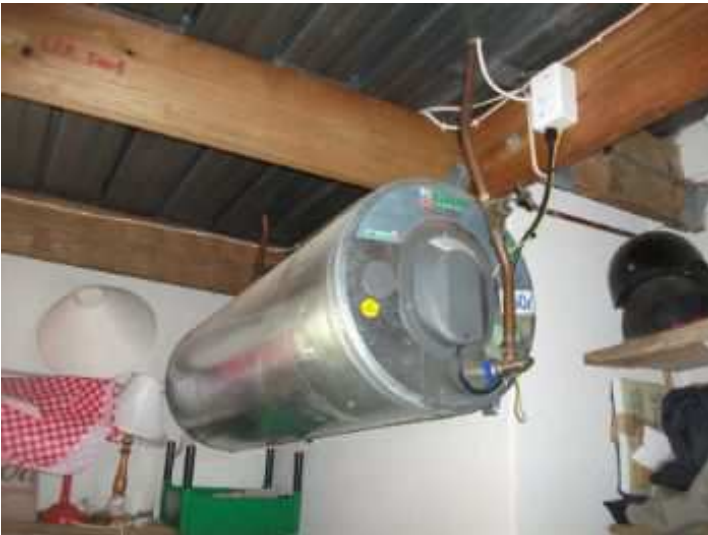
- No drip tray installed.
- No earth bonding strap between hot and cold water supply has been observed.
- Hot water pipes should be copper or suitably rated (70° C) PVC or composite metal sheathed (white) pipe. Plumber doing compliance certificate inspection to check and report.

Geyser installation in garage

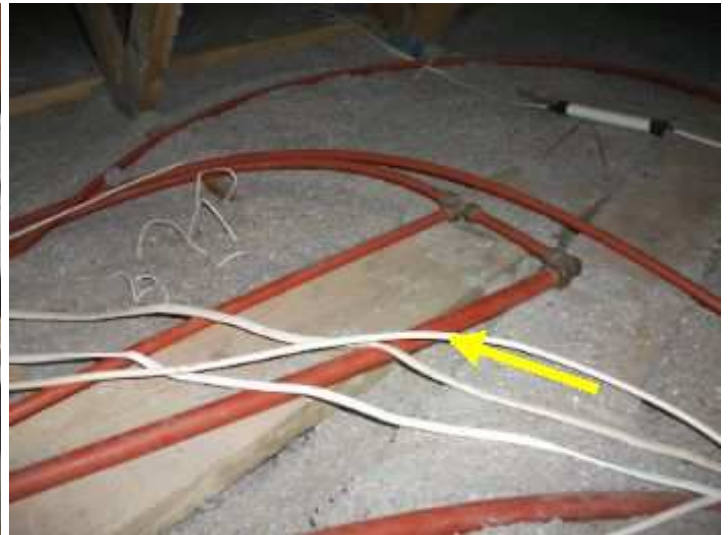
Geyser - hot water pipes should be copper or suitably rated (70 deg. C) plastic or composite pipe

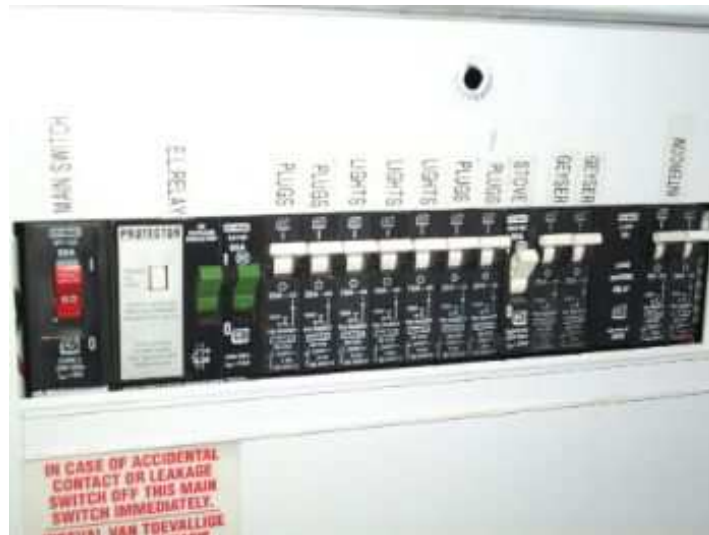
First floor lounge south wall - DB board in good condition

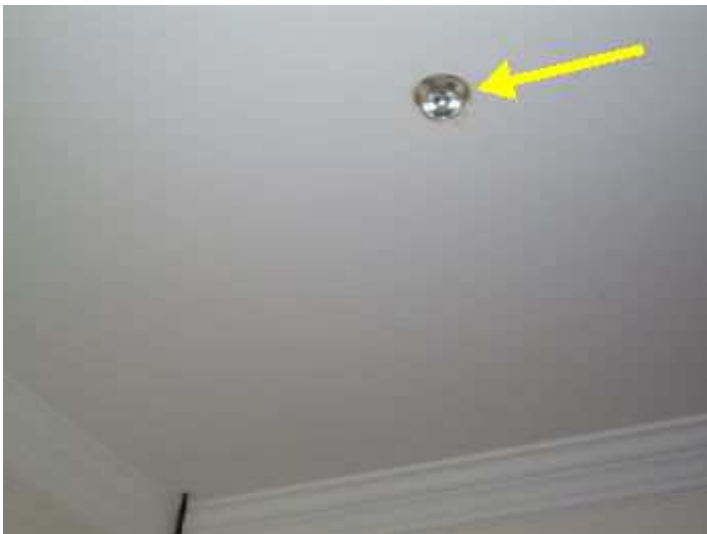
First floor lounge - down light fitting shell missing

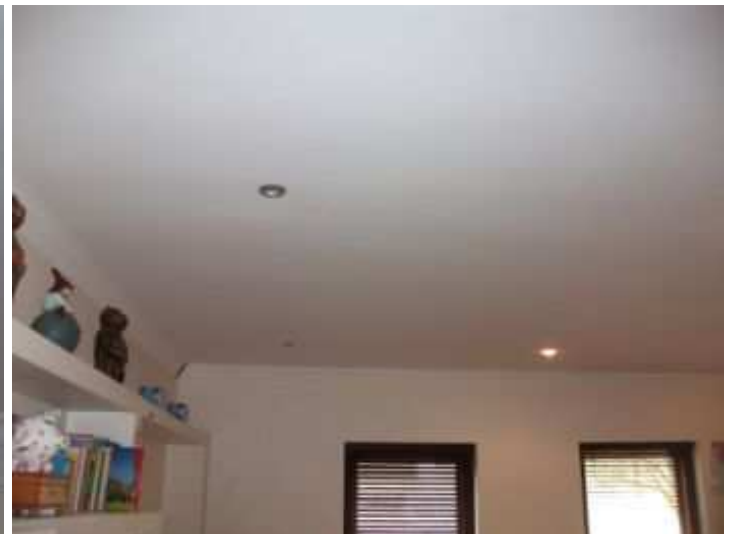
First floor lounge - some down lights not working

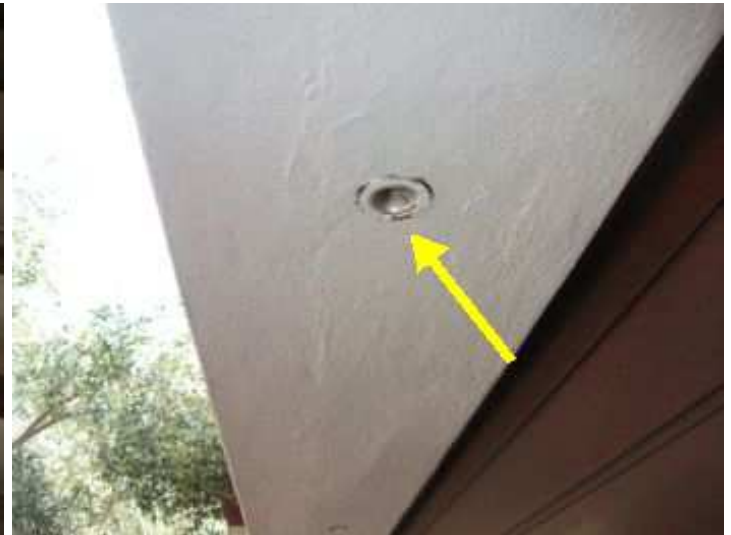
Garage door - rusted down lights

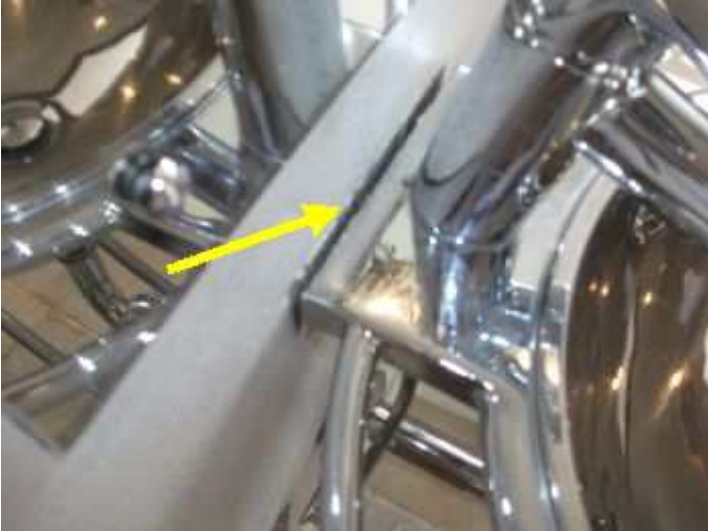
Bedroom 1 en-suite bathroom - basin loose
