HouseCheck

Inspection Report

22 Main Road, Sampleville

Inspection prepared for: Sample Client
Date of Inspection: 5/24/2013 Time: 10:00 AM
Age of Home: ± 10 years
Weather: Clear

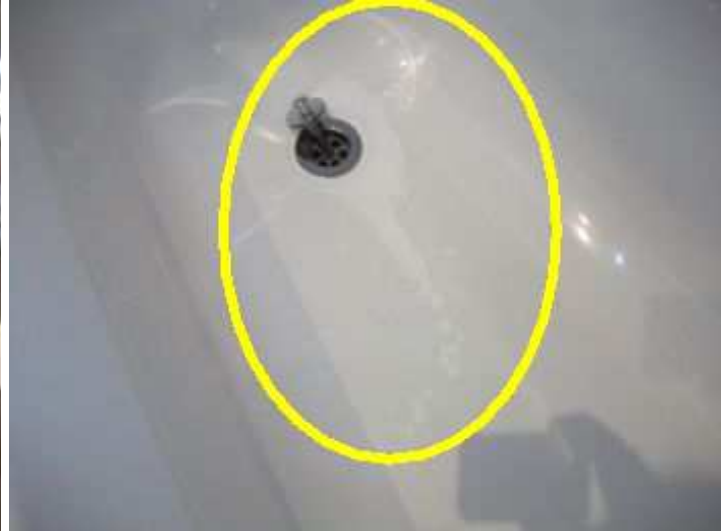
Bedroom 2 en-suite bathroom - bath marked or stained

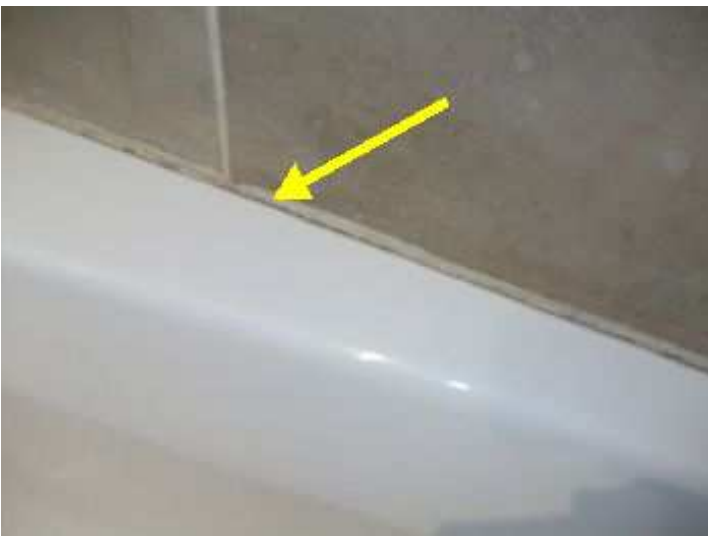
Bedroom 2 en-suite bathroom - bath not properly sealed at wall intersection

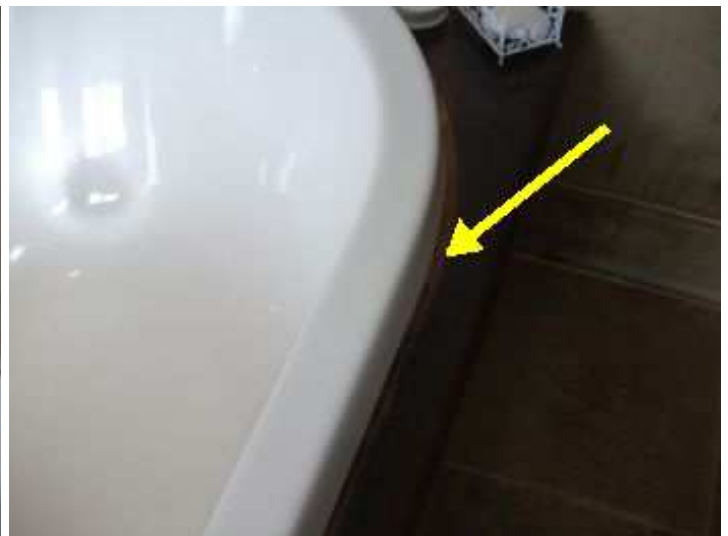
Main en-suite bathroom - movement between bath and enclosure visible

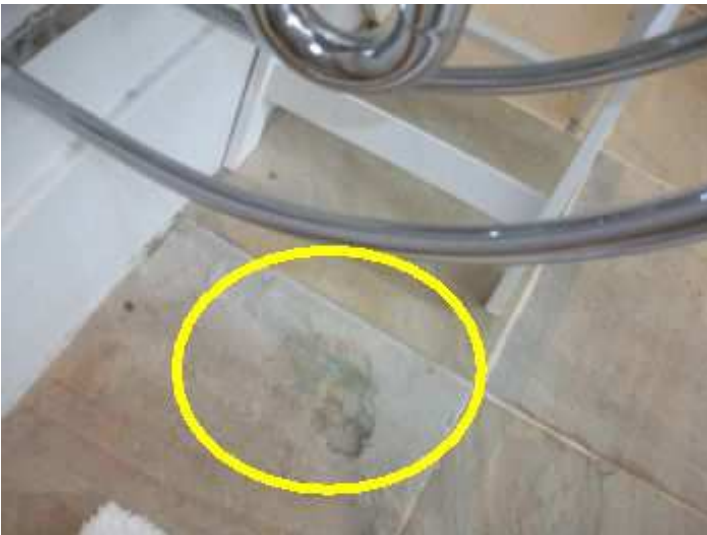
Bedroom 1 en-suite bathroom - water drip marks below basin waste pipe

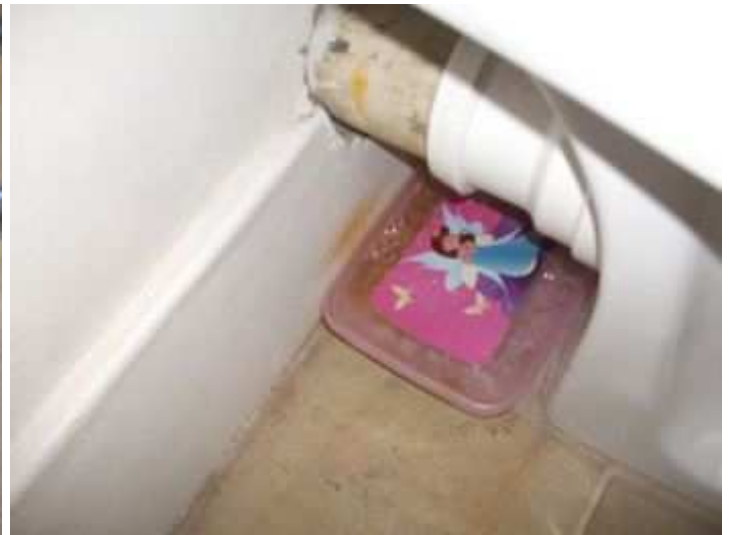
Bedroom 1 en-suite bathroom - possible leak at toilet waste pipe

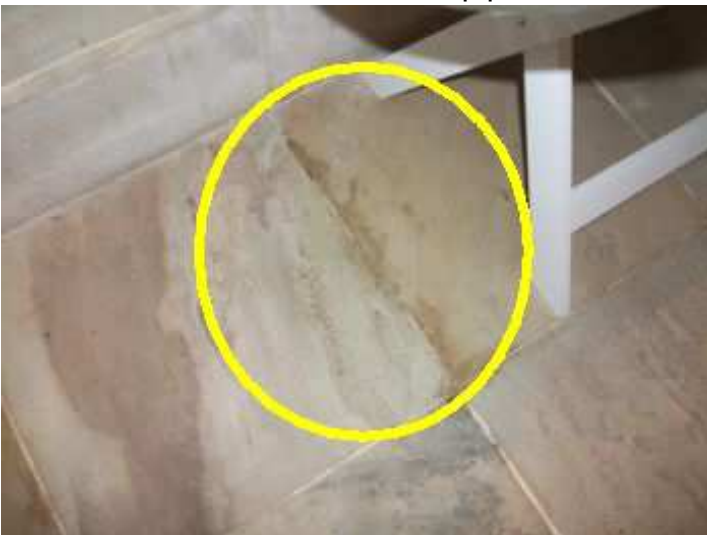
Bedroom 2 en-suite bathroom - water mark below basin - waste pipe dry at inspection

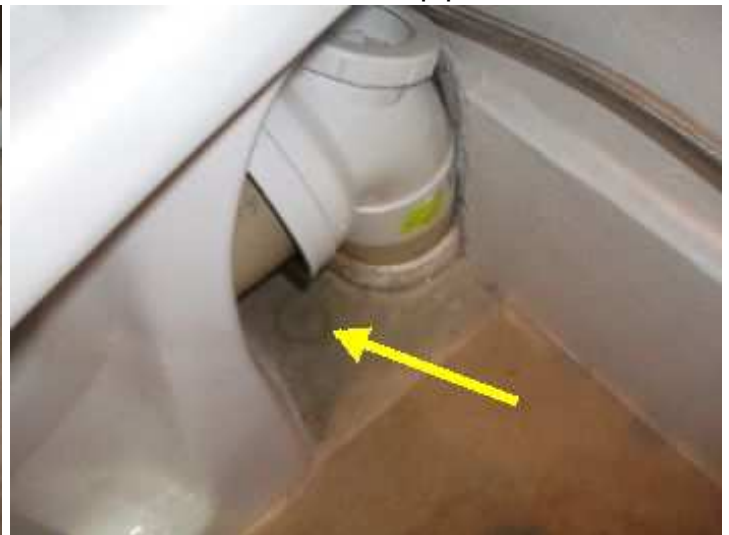
Bedroom 2 en-suite bathroom - leak at toilet waste pipe

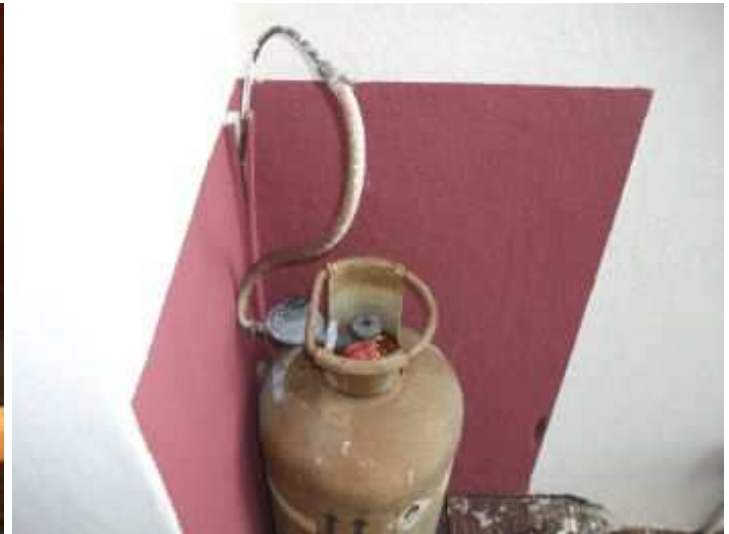
Dining room - external gas installation appears to comply with regulations
