## ROOF INSPECTION

Property address: SAMPLE - Special Items Inspection  
Johannesburg Gauteng 0000

Date of inspection: 2023 / 05 / 01

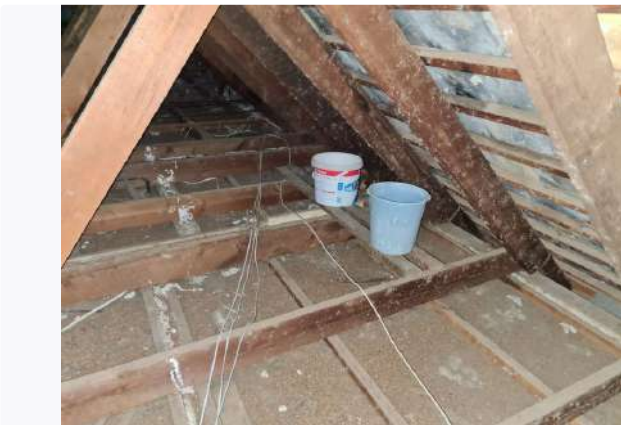
Ref # 4.1 - Containers in the roof due to active or previous roof leaks.

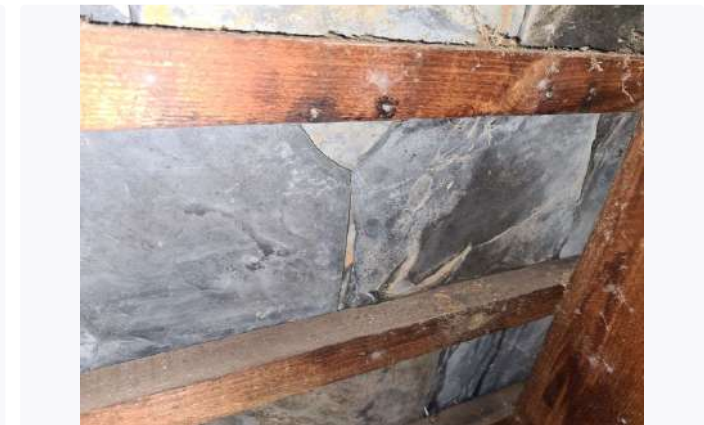
Ref	Item	Description	Defects Observed	Action Recommended
4.1	Roof covering	Slates	<p>Some roof slates loose, cracked, damaged or dislodged. Moss growth on some areas of the roof covering. Although moss have the tendency for water retention it does not cause damage to the slates. Careful consideration should be taken before any removals are done. The possible additional damage to the brittle slates and the unavailability of new slates could be problematic. <b>MATERIAL DEFECTS</b></p>	Urgent repairs recommended

Ref # 4.1 - Some roof slates loose, cracked, damaged or dislodged.

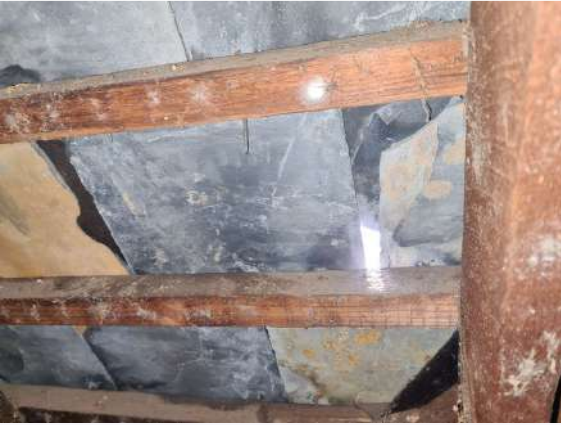
Ref # 4.1 - Some roof slates loose, cracked , damaged or dislodged.

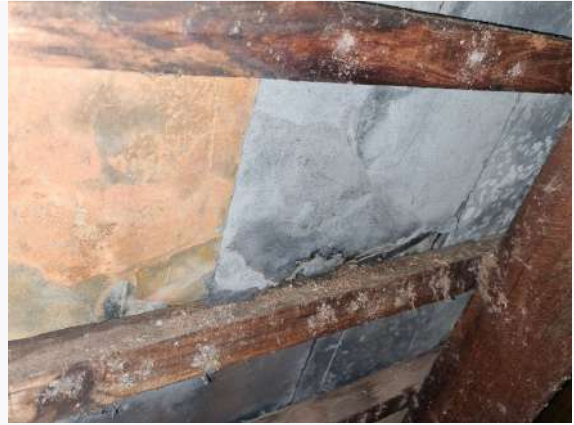
Ref # 4.1 - Some roof slates loose, cracked , damaged or dislodged.

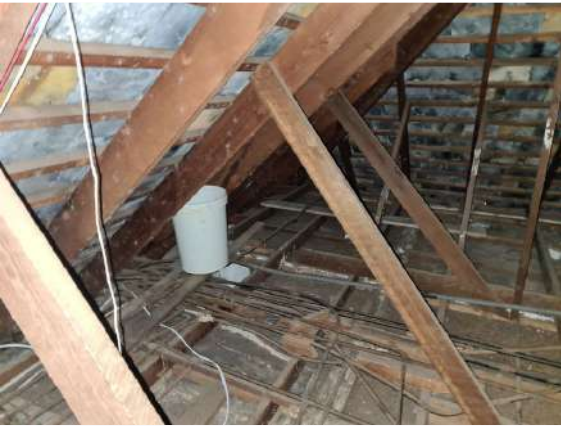
Ref # 4.1 - Containers in the roof due to active or previous roof leaks.

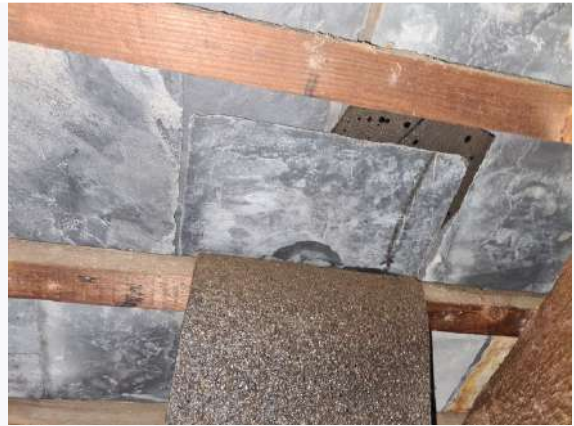
Ref # 4.1 - Some roof slates loose, cracked , damaged or dislodged.

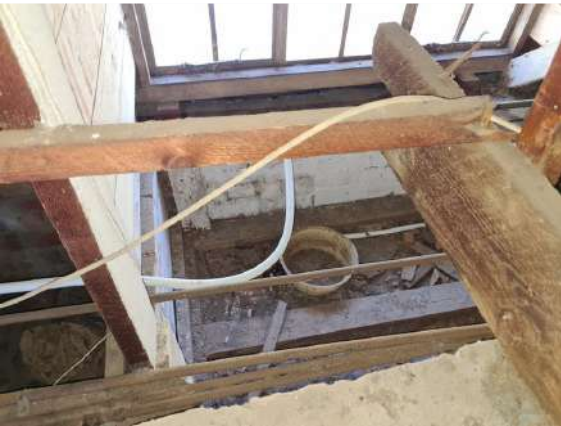
Ref # 4.1 - Containers in the roof due to active or previous roof leaks.

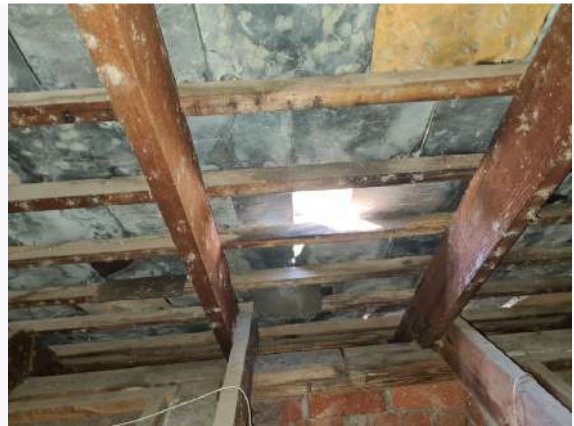
Ref # 4.1 - Some roof slates loose, cracked , damaged or dislodged.

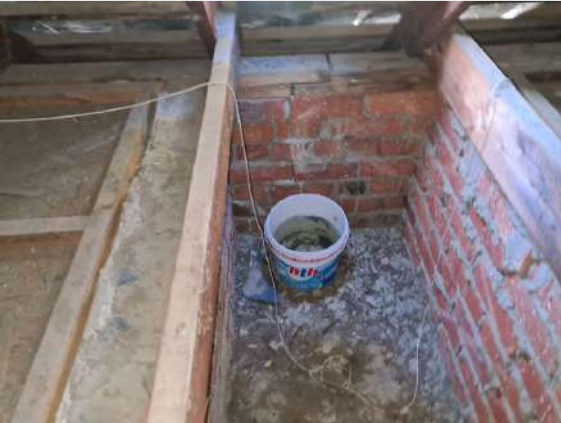
Ref # 4.1 - Containers in the roof due to active or previous roof leaks.

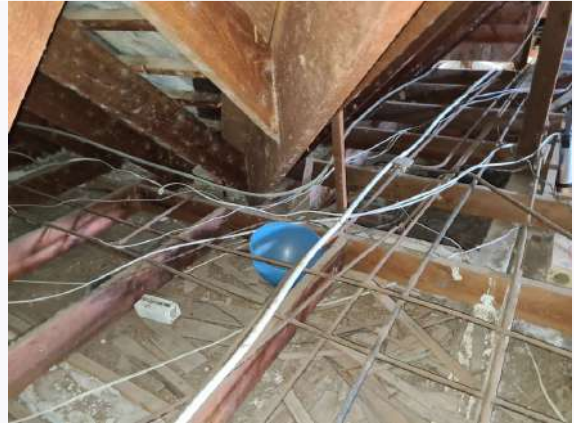
Ref # 4.1 - Containers in the roof due to active or previous roof leaks.

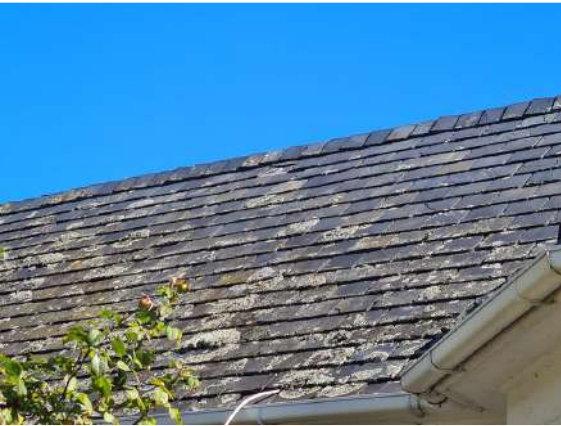
Ref # 4.1 - Some roof slates loose, cracked , damaged or dislodged.

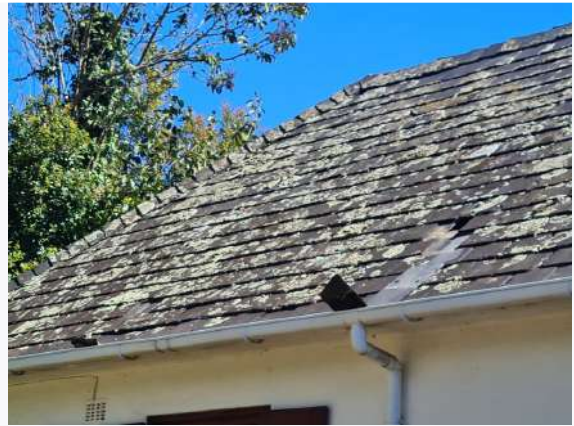
Ref # 4.1 - Some roof slates loose, cracked , damaged or dislodged.

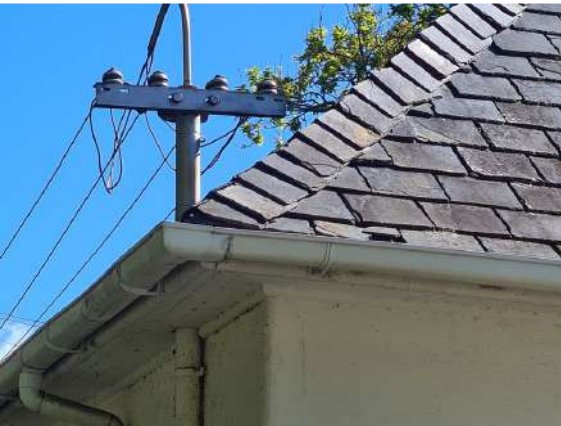
Ref # 4.1 - Some roof slates loose, cracked , damaged or dislodged.

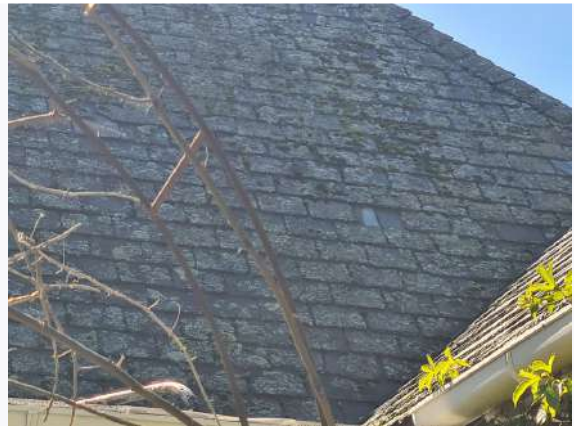
Ref # 4.1 - Some roof slates loose, cracked , damaged or dislodged.

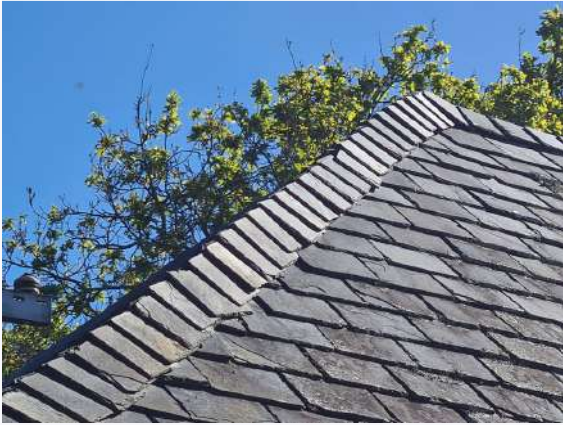
Ref # 4.1 - Some roof slates loose, cracked , damaged or dislodged.

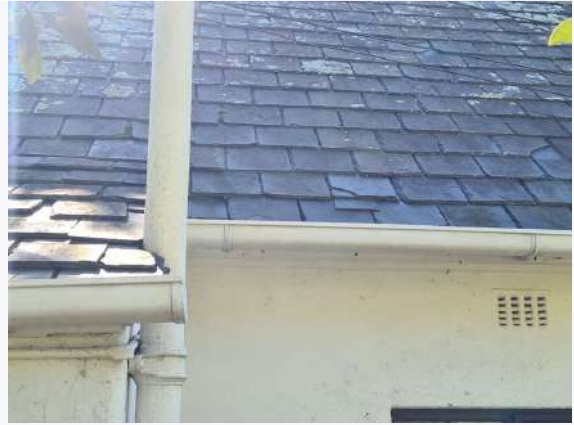
Ref # 4.1 - Some roof slates loose, cracked , damaged or dislodged.

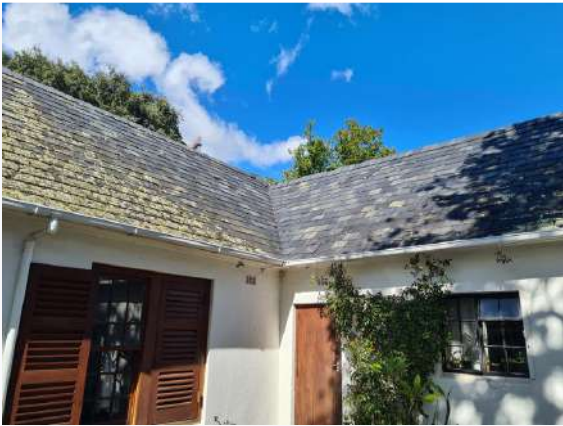
Ref # 4.1 - Some roof slates loose, cracked , damaged or dislodged.

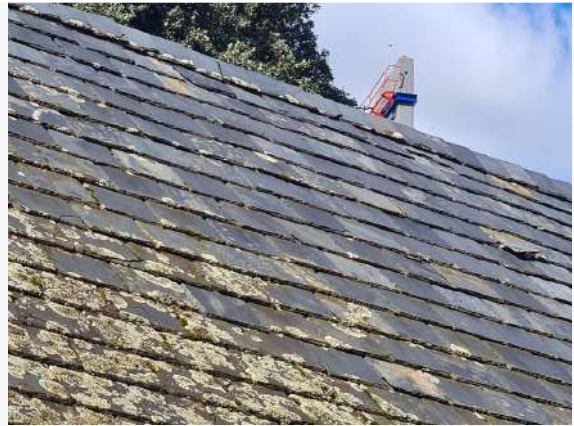
Ref # 4.1 - Moss growth on some areas of the roof covering.

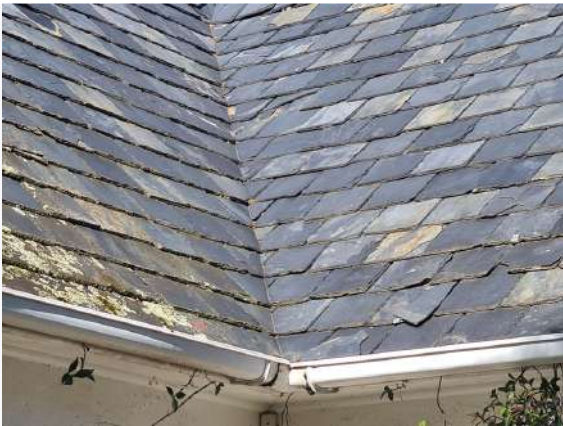
Ref # 4.1 - Some roof slates loose, cracked , damaged or dislodged.

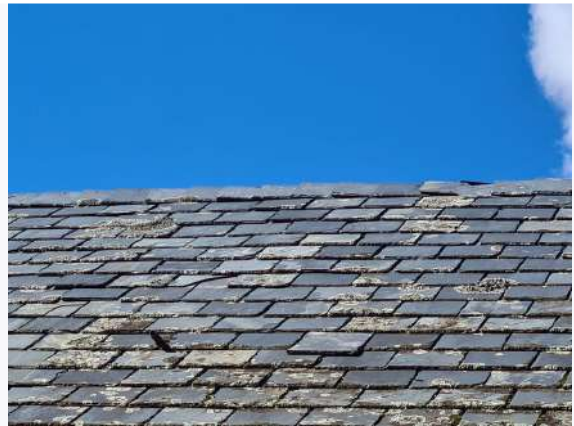
Ref # 4.1 - Some roof slates loose, cracked , damaged or dislodged.

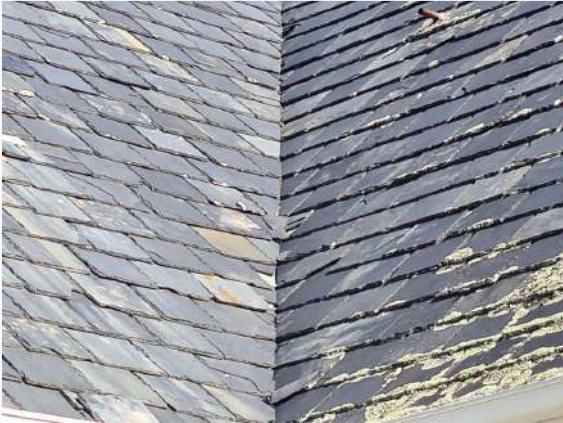
4.2	Valleys	Open valley	<p>Some dislodged roof slates in the valley gutters. Valley gutters filled with debris. Will require cleaning on a regular basis to prevent blockages and possible water penetration into the interior. <b>MATERIAL DEFECTS</b></p>	Urgent maintenance recommended

Ref # 4.2 - Some dislodged roof slates in the valleys.

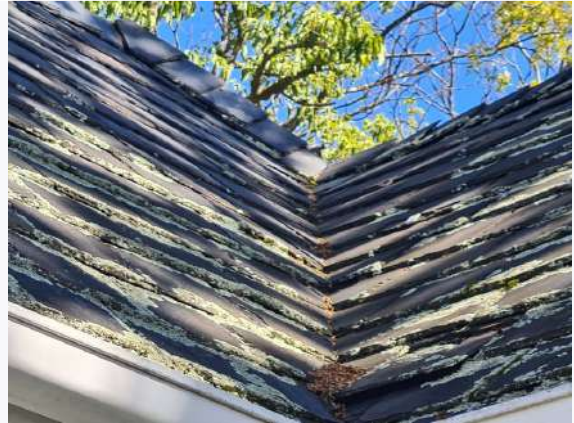
Ref # 4.2 - Valleys filled with debris.

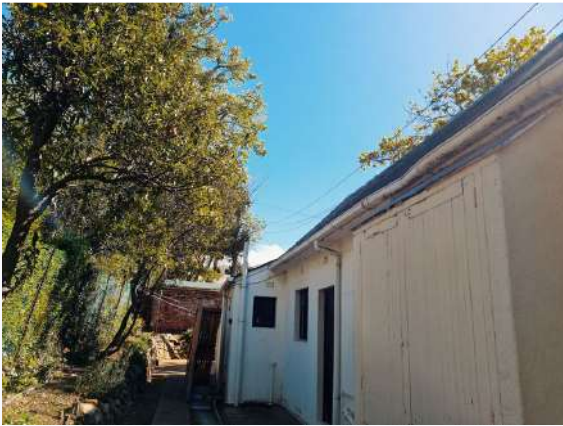
4.3	Gutters & Downpipes	PVC plastic	<p>Gutters sagging in places and filled with debris. Gutters filled with debris. Gutters require cleaning on a regular basis to prevent sagging and water retention. <b>MATERIAL DEFECTS</b></p>	Urgent maintenance recommended

Ref # 4.3 - Gutters sagging in places and filled with debris.

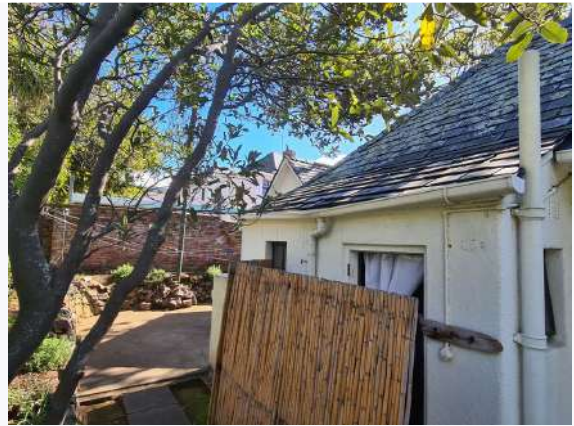
Ref # 4.3 - Gutters sagging in places and filled with debris.

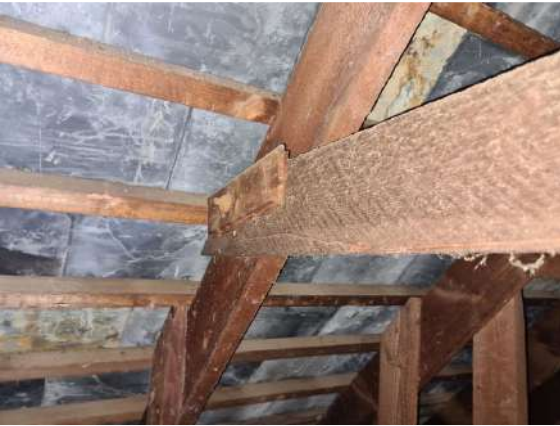
Ref	Item	Description	Defects Observed	Action Recommended
5.1	Trusses & Rafters	Old timber roof structure (carpenter-built)	Some structural timber members of the roof with minor splits / cracks. <b>MATERIAL DEFECTS</b>	Urgent maintenance recommended

Ref # 5.1 - Minor cracks in some roof timber joists.

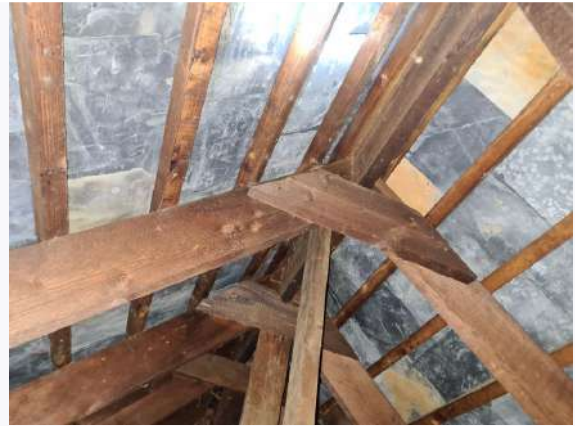
Ref # 5.1 - Minor cracks in some roof timber joists.

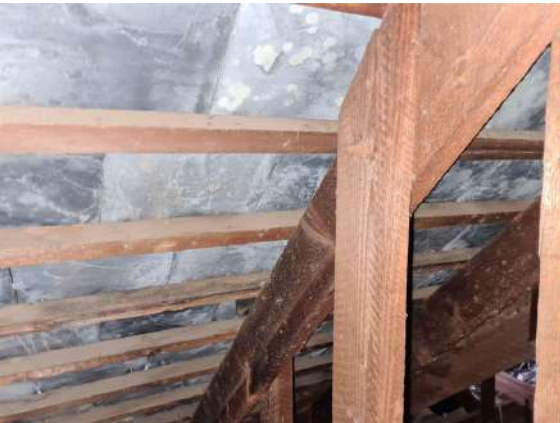
Ref # 5.1 - Minor cracks in some roof timber joists.

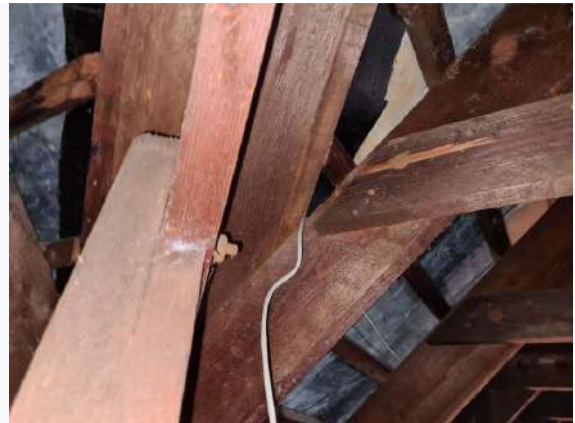
Ref # 5.1 - Minor cracks in some roof timber joists.

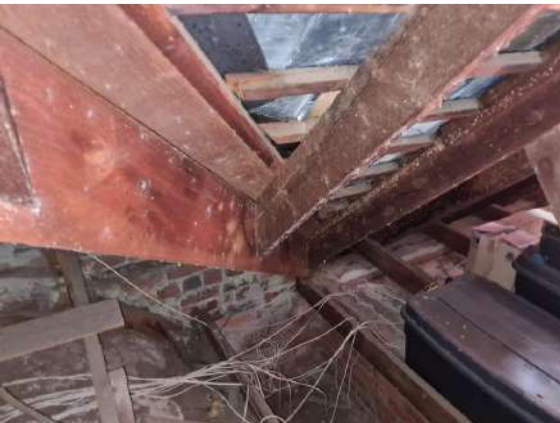
Ref # 5.1 - Minor cracks in some roof timber joists.

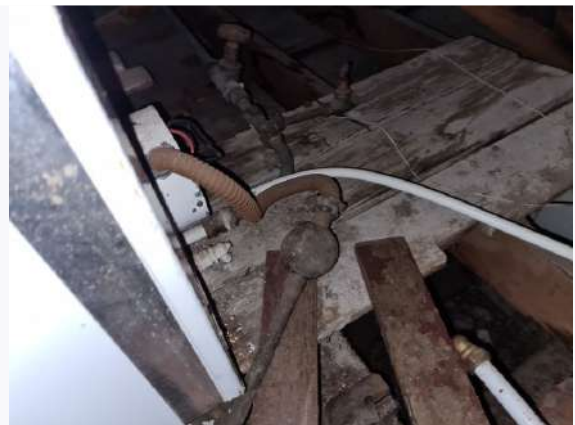
6.2	Geyser isolator switch	An electrical isolator switch must be installed within 1.5m of the geyser	No isolator switch installed. <b>MATERIAL DEFECTS</b>	Urgent repairs recommended

Ref # 6.2 - No isolator installed.

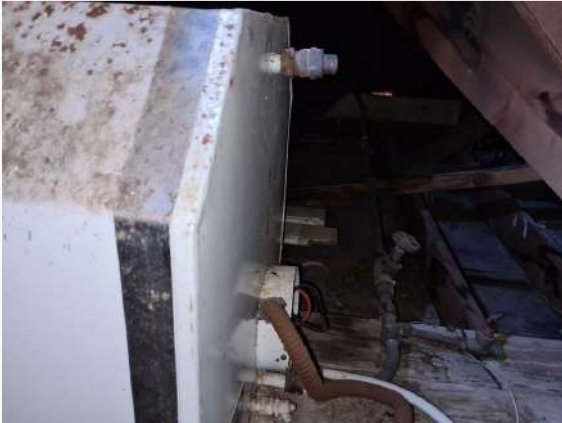
6.3	Thermostat cover plate	The cover plate to the electrical connection to the geyser thermostat must be fitted	Thermostat cover plate not fitted / loose. <b>MATERIAL DEFECTS</b>	Urgent repairs recommended

Ref # 6.3 - Thermostat cover plate not fitted / loose.
