HouseCheck

Inspection Report

22 Main Road, Sampleville

Inspection prepared for: Sample Client
Date of Inspection: 5/24/2013 Time: 10:00 AM
Age of Home: ± 10 years
Weather: Clear

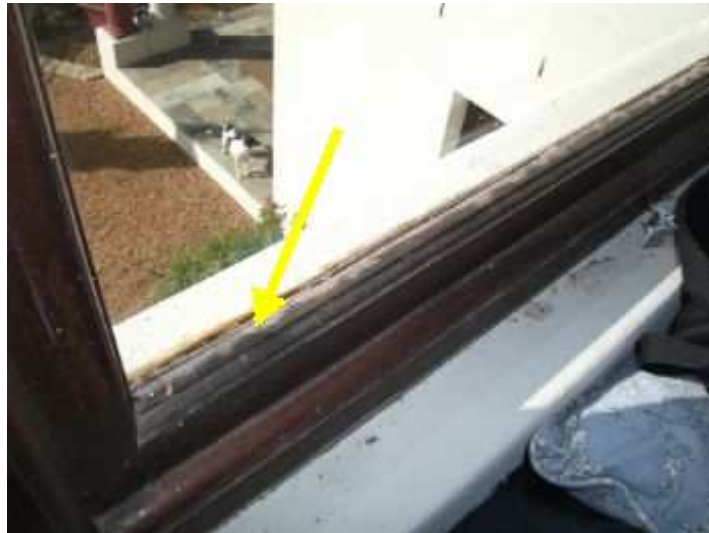
Garage - water ingress between glass and frame as a result of dry glazing putty

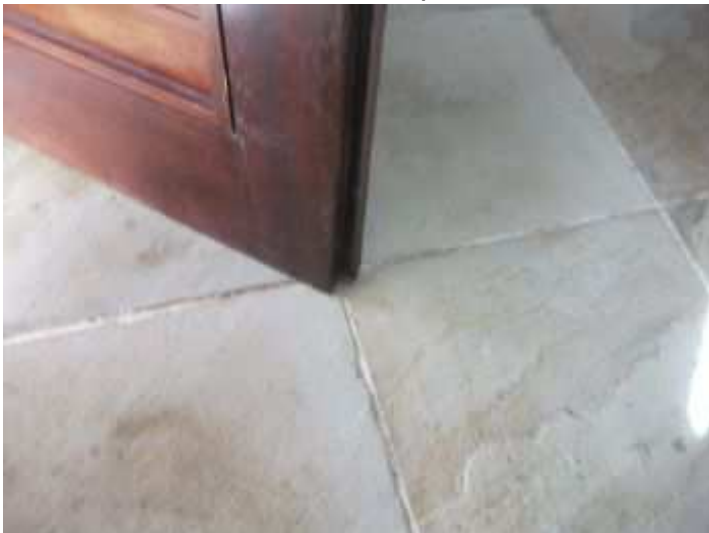
Family room - door catching on floor tiles

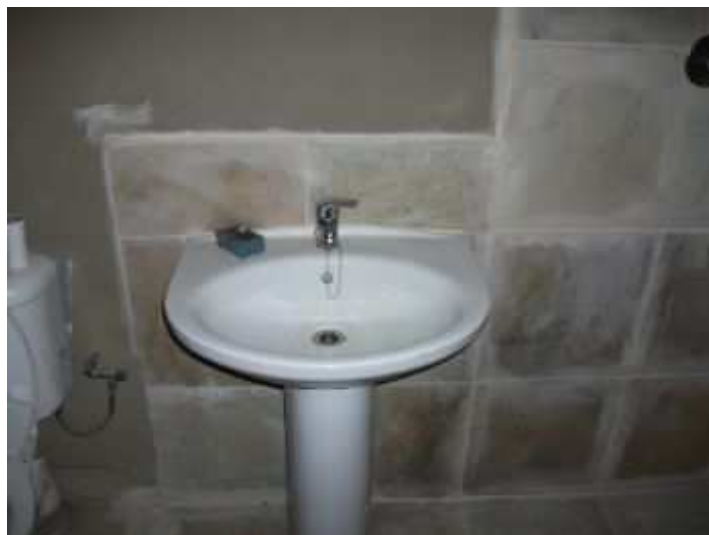
Guest bedroom en-suite bathroom - tile cleaning and painting not finished

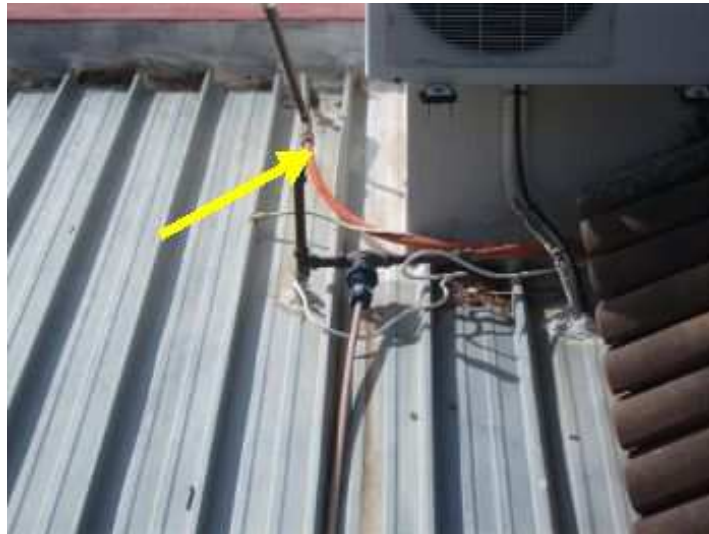
- No fire door installed between garage and first floor lounge.
- Geysers had no drip tray fitted and no earth bonding strap between hot and cold water was observed. Hot water supply pipes was plastic "polycop" and not suitable for hot water supply. Plumber doing compliance certificate inspection to check and comment.

Geyser - hot water supply from geyser should be copper pipe or plastic composite pipe

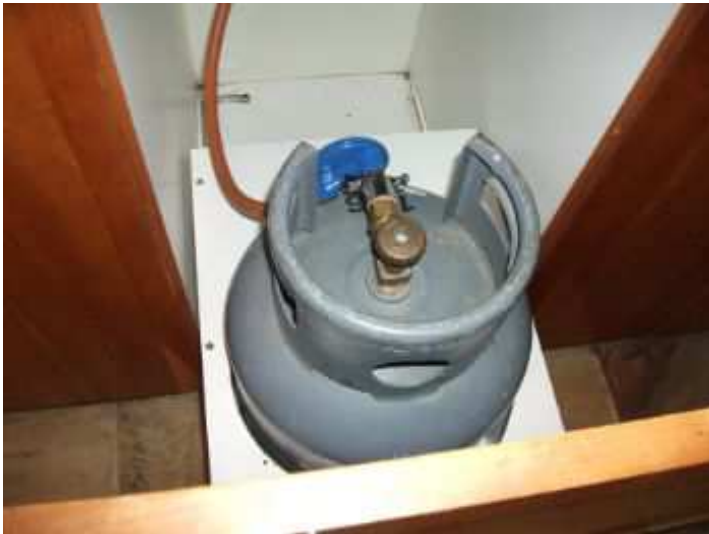
Kitchen - internal gas installation appears to comply with regulations
